Micro Surfacing Improves Pavement Performance on Lee Road 159

As part of the NCAT-MnROAD Pavement Preservation Group (PG) Study, six micro surfacing test sections were placed on Lee County Road 159, a low traffic volume road located in Auburn, Alabama. Treatments included single, double and cape seal applications and have been monitored periodically since 2012 to assess structural condition, surface distress, and ride quality. In addition,

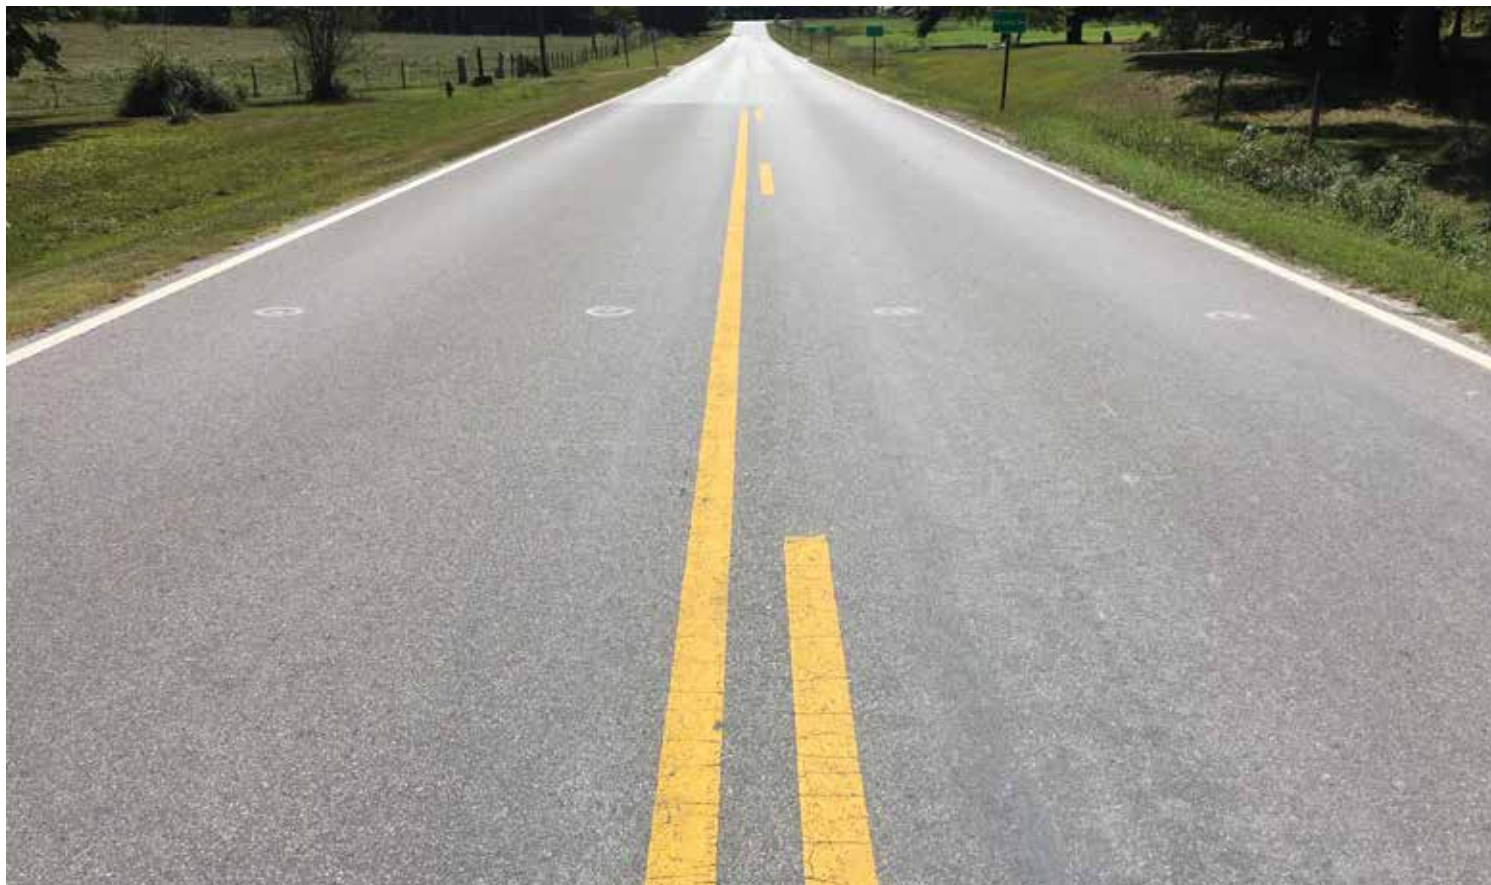
Overall condition of scrub cape seal on Lee Road 159.

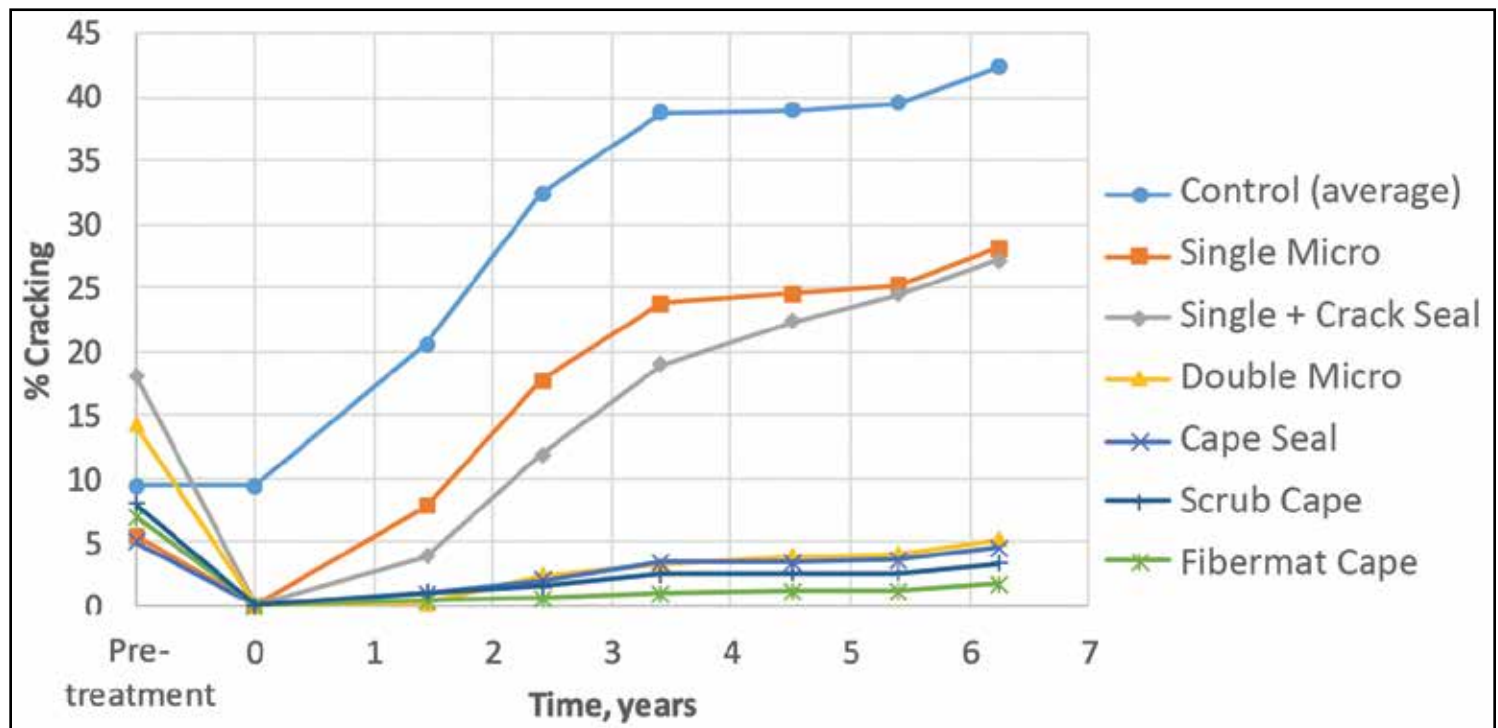
Figure 1. Cracking progression over time.

As sections approach their seventh year in service, the main type of distress observed has been cracking. Even though micro surfacing is not considered a crack mitigation treatment, its application has improved cracking performance compared to the control sections, as shown in Figure 1. While the control sections have deteriorated rapidly, treated sections have developed far less cracking since the treatments were constructed. Furthermore, the sections can be separated into three

groups based on performance: untreated, single layer applications, and multi-layer or cape seal applications. As expected, more robust treatments have resulted in improved cracking resistance.

To provide a fair assessment of treatment performance, it is important to take into account the condition of the pavement at the time of application. Multi-layer and cape seal applications have not yet returned to their pretreatment level of cracking and remain in good condition, with less than 5% cracking by area. Single-layer applications have over 20% cracking. However, the section that included crack sealing exhibited a significantly higher amount of pretreatment cracking. When crack sealing was used in combination with micro surfacing, the test section that started with 18% cracking (pretreatment) increased to 27% after more than six years of service, for a change of only 9%. On the other hand,

the stand-alone single layer micro surface increased from 5% pretreatment cracking to 28% currently, for an increase of 23% cracking over the study period.
