**MoDOT**

Product Development 96-004

# Scrub Seal

Initial Report

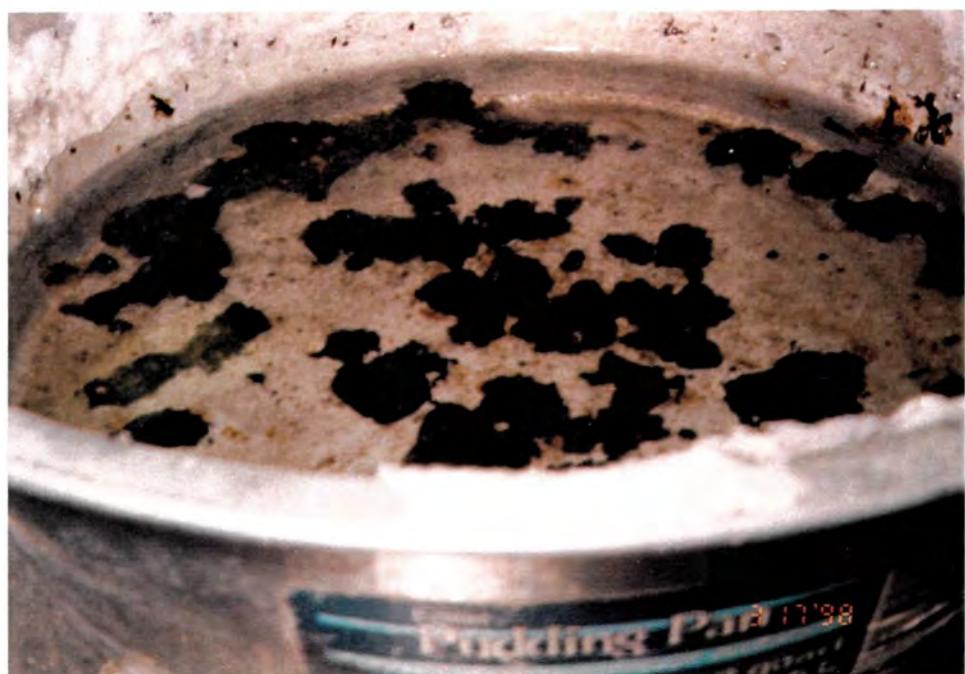
Photo #1: Samples of the seal soaking in salt brine. Oily clumps of the emulsion were floating on the surface and can be seen on the sides of the container. March 17, 1998; District 1, Andrew County Business Route 71

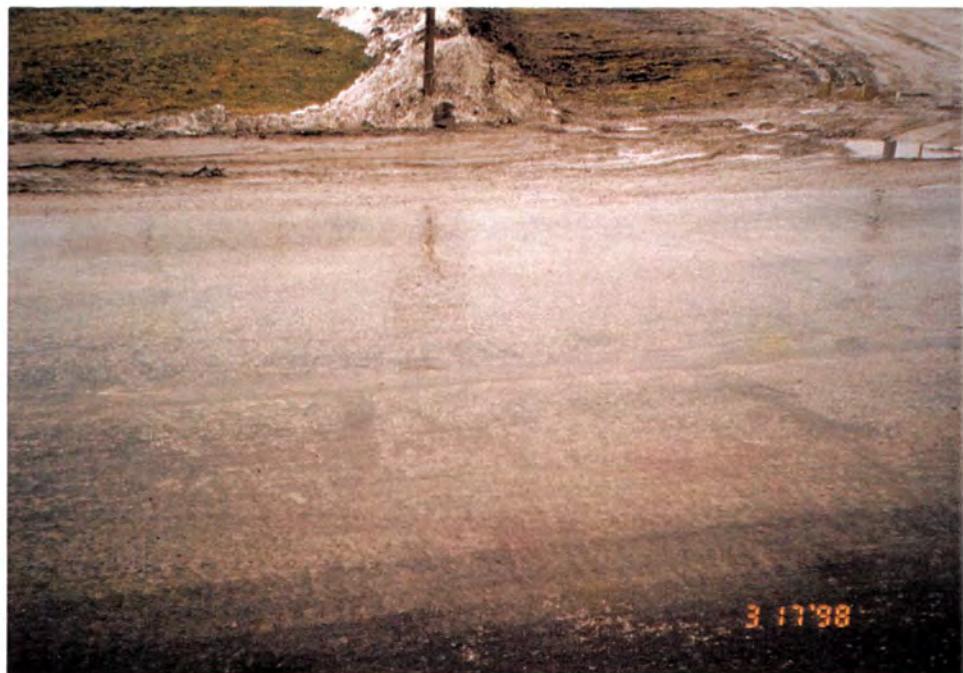
There was also a significant amount of wear in the wheelpaths on Route 71, so heavy in some area that little to no seal remained. This was especially highlighted in the areas next to the various turnarounds. Due to the rain that day, the amount of wear could not always be clearly defined, but it was still apparent.

Photo #2: Wear and loss of seal on the surface. March 17, 1998; District 1, Andrew County Business Route 71

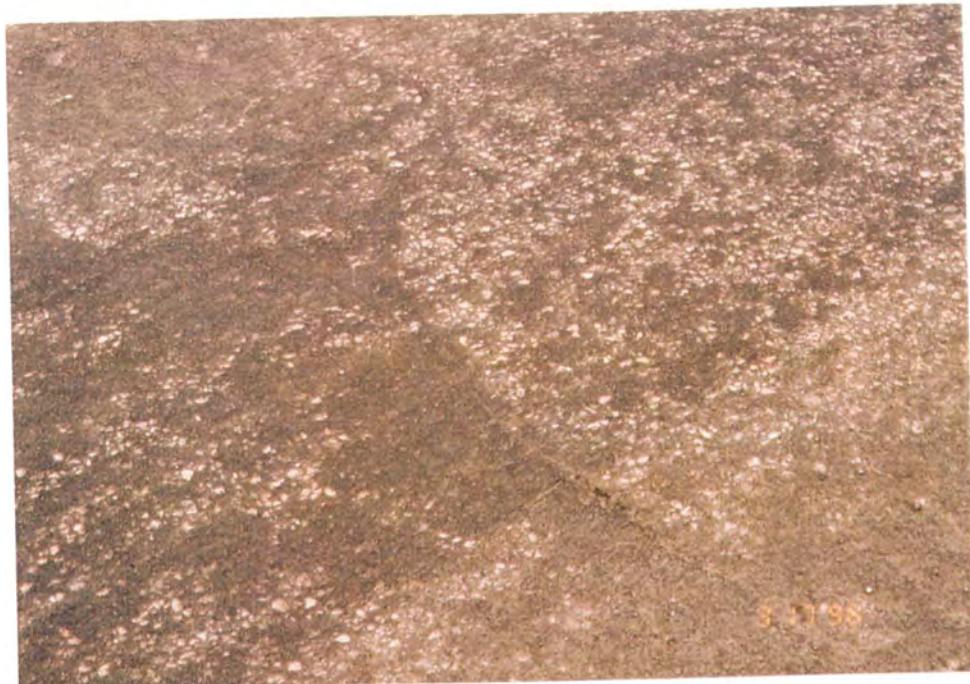
Photo #3: A close-up view of the surface showing wear and loss of seal. March 17, 1998; District 1, Andrew County Business Route 71

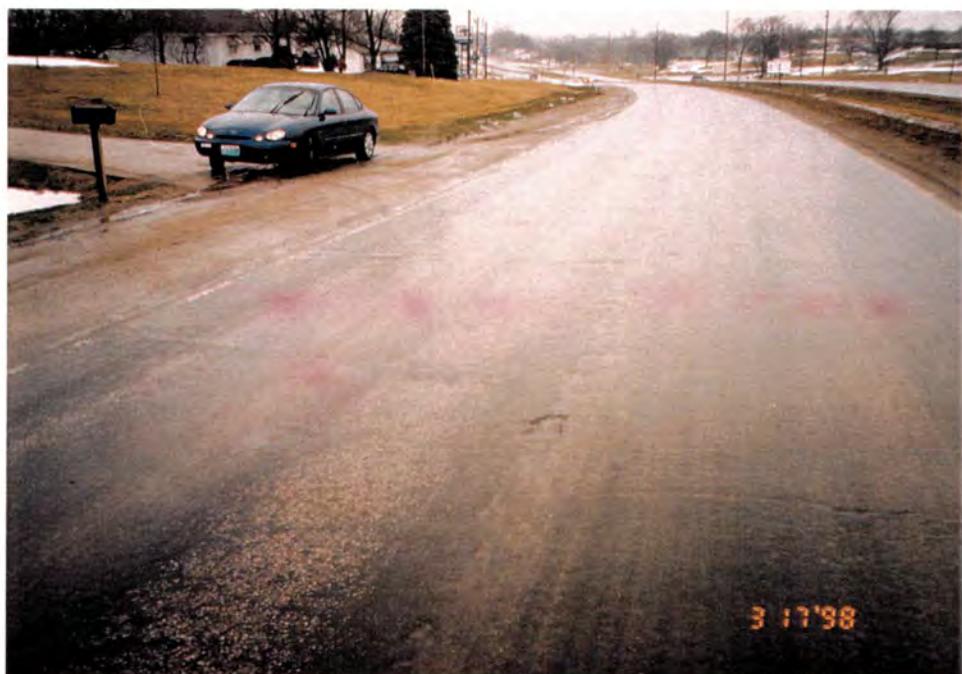
The aggregate used in the majority of this project was washed river sand. A small portion of the project used wet bottom boiler slag, obtained from St. Joseph Power and Light. A total of 50 tons of the wet bottom boiler slag was used and its resistance to wear, as compared to the sand used, is phenomenal. Mr. Preuss was very impressed by the behavior of the slag so far, especially when considered with the extremely poor performance of the seal in this particular location.

Photo #4: The driving lane (on the left) with washed sand aggregate and showing wear; the section having wet bottom boiler slag is on the right and is showing little to no wear. March 17, 1998; District 1, Andrew County Business Route 71

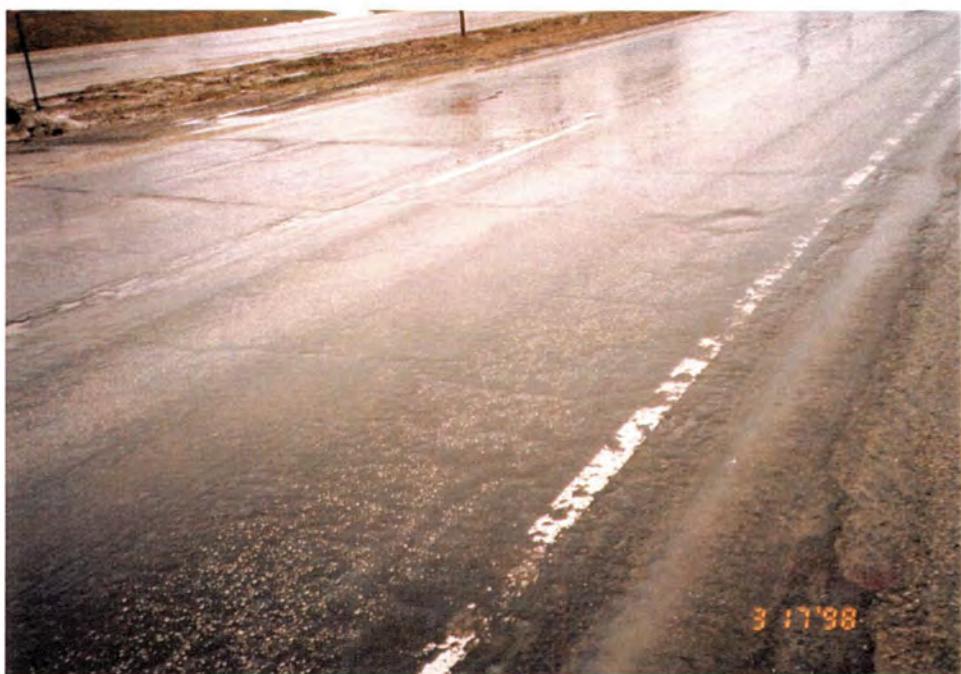
Photo #5: A second view of Photo #4 showing the difference in wear between the seal using sand as aggregate and wet bottom boiler slag as aggregate. March 17, 1998; District 1, Andrew County Business Route 71

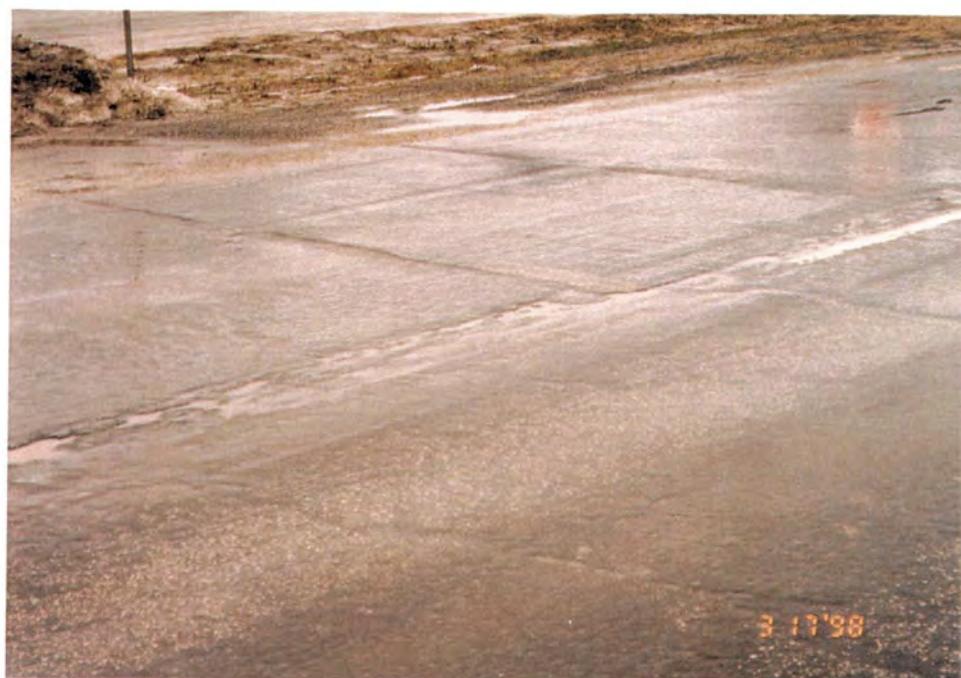
Photo #6: A slightly closer view of Photo #5. March 17, 1998; District 1, Andrew County Business Route 71

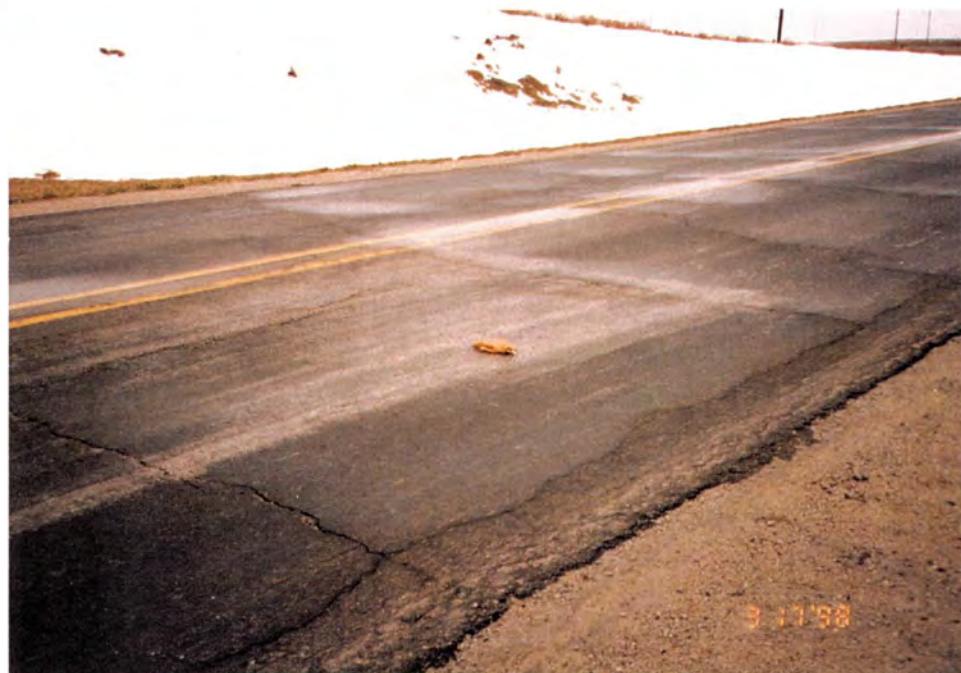
This seal looks very good and is arguably the best looking one of the ten. There are two instances where minor damage has occurred. The first is in the outer wheelpath heading toward Route 116, where several sizable popouts have been noticed going up a hill. The other is in a slight dip in the apex of a horizontal curve, at the bottom of an uphill right hand curve. It appears that a raised snowplow may have bounced on the pavement, causing a sizable, lane wide scrape.

Photo #1: A scrape in the surface most likely due to a snowplow. March 17, 1998; District 1, Buchanan County Route JJ

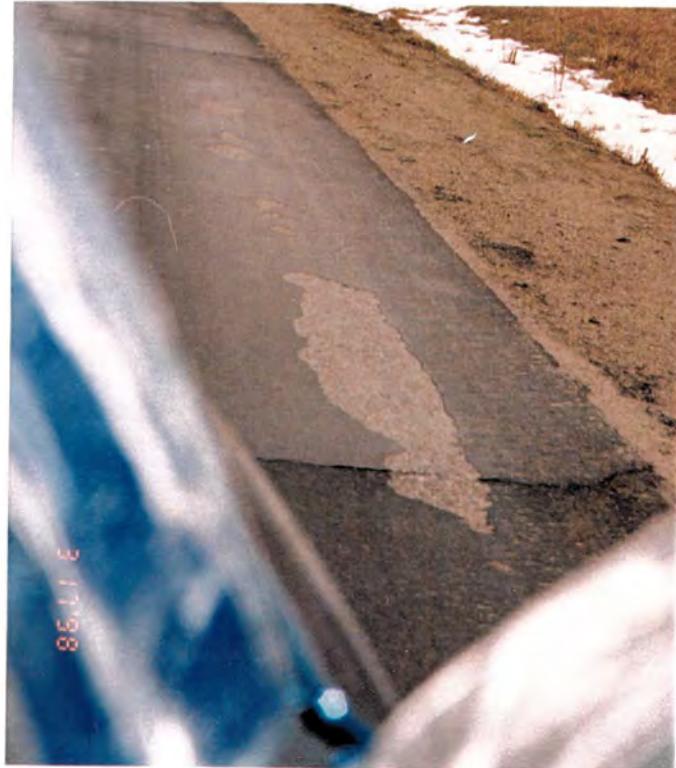
Photo #2: A loss of seal in the wheelpath. March 17, 1998; District 1, Buchanan County Route JJ

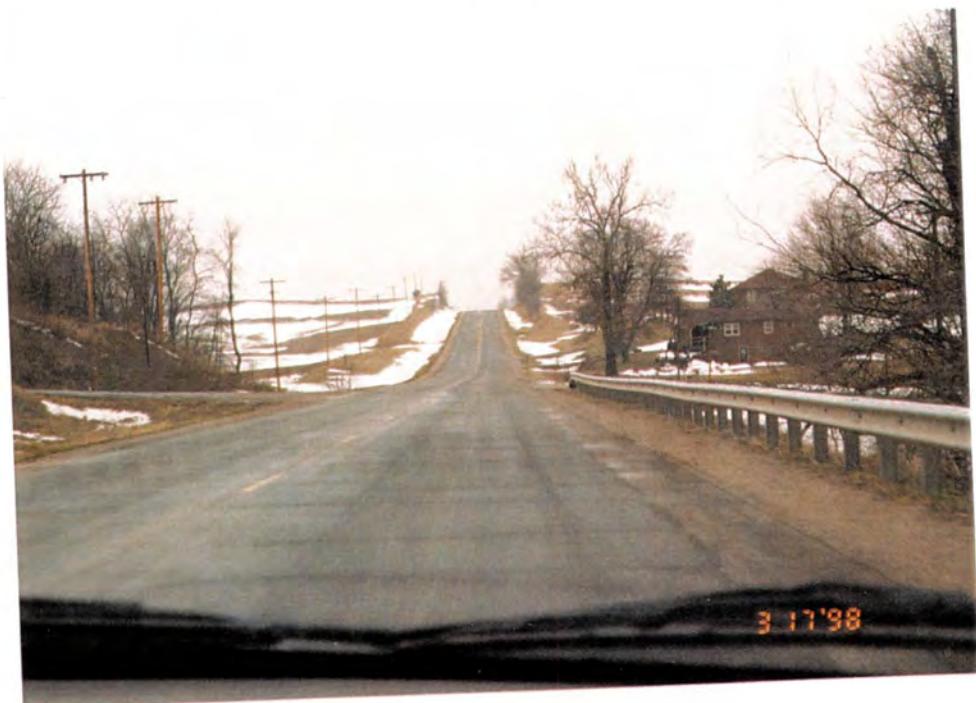
Photo #3: A driveby view of the surface. March 17, 1998; District 1, Buchanan County Route JJ

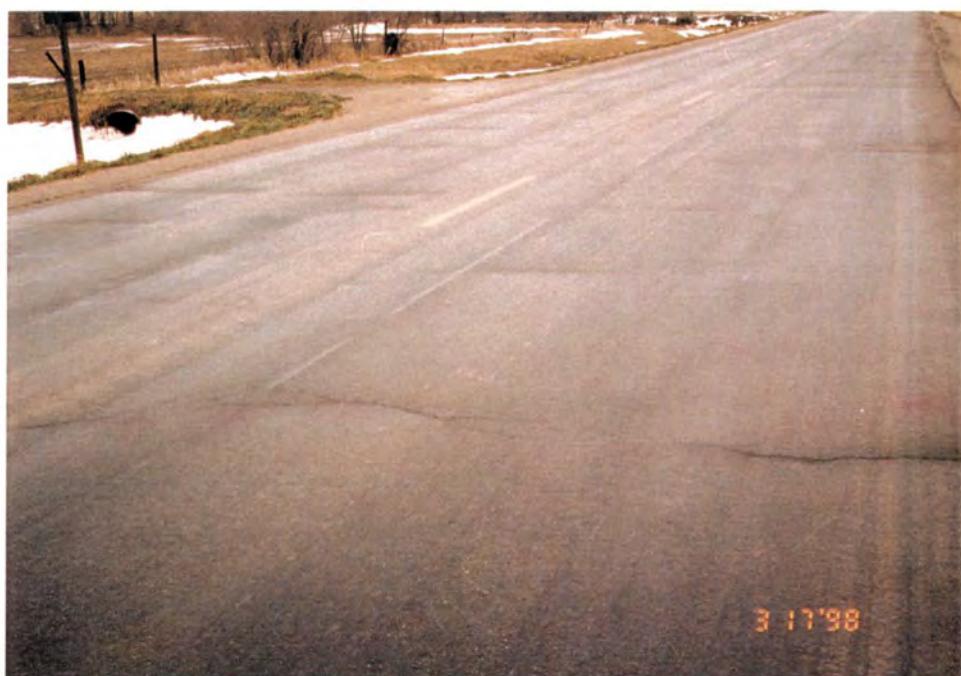
Photo #4: A view of the surface from around 6' above. March 17, 1998; District 1, Buchanan County Route JJ

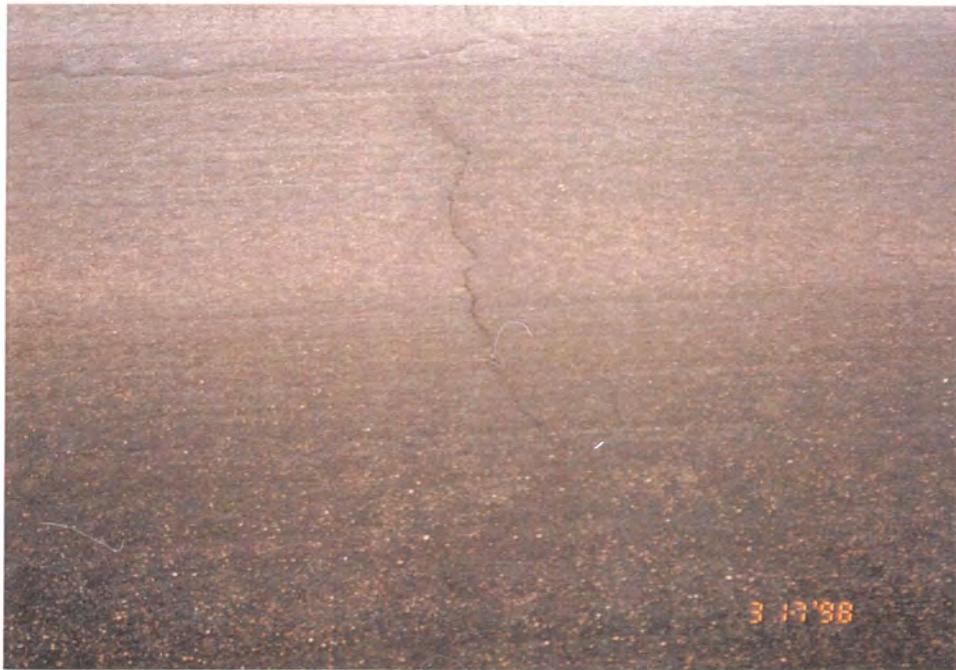
Photo #5: A view of a crack and the texture of the surface. March 17, 1998; District 1, Buchanan County Route JJ

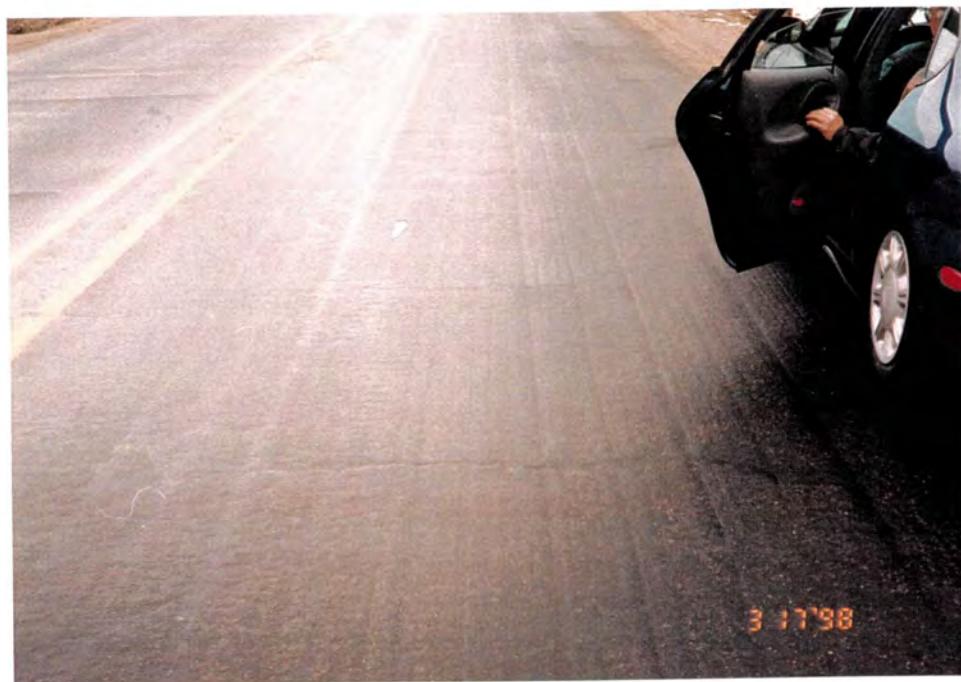
Photo #6: Another view of the surface from around 6' above. March 17, 1998; District 1, Buchanan County Route JJ

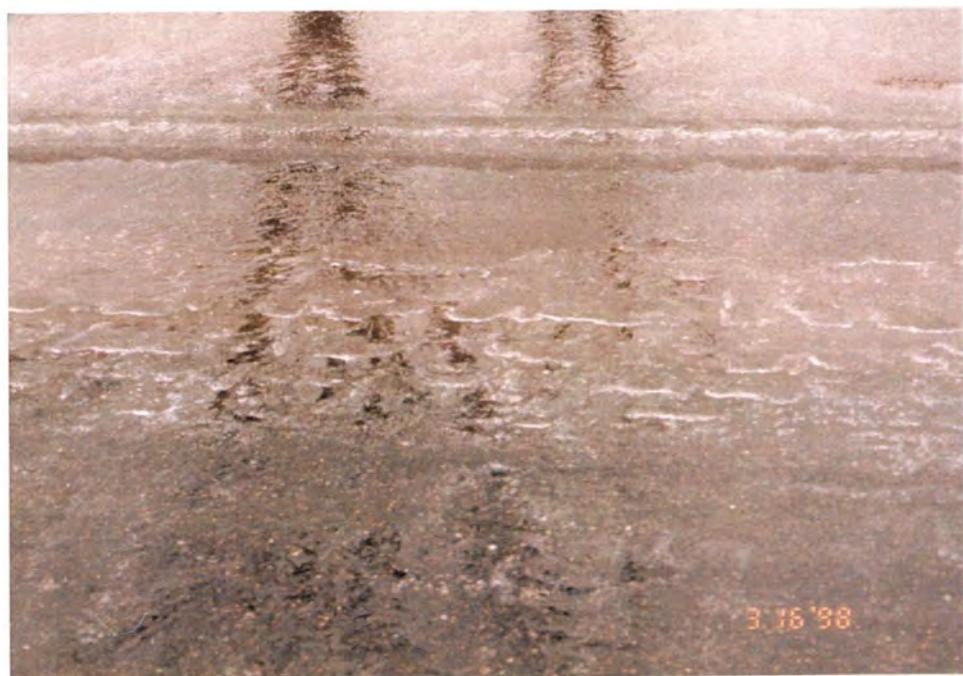
Photo #1: Sheet flow on the driving surface. March 16, 1998; District 2, Chariton County Route 24

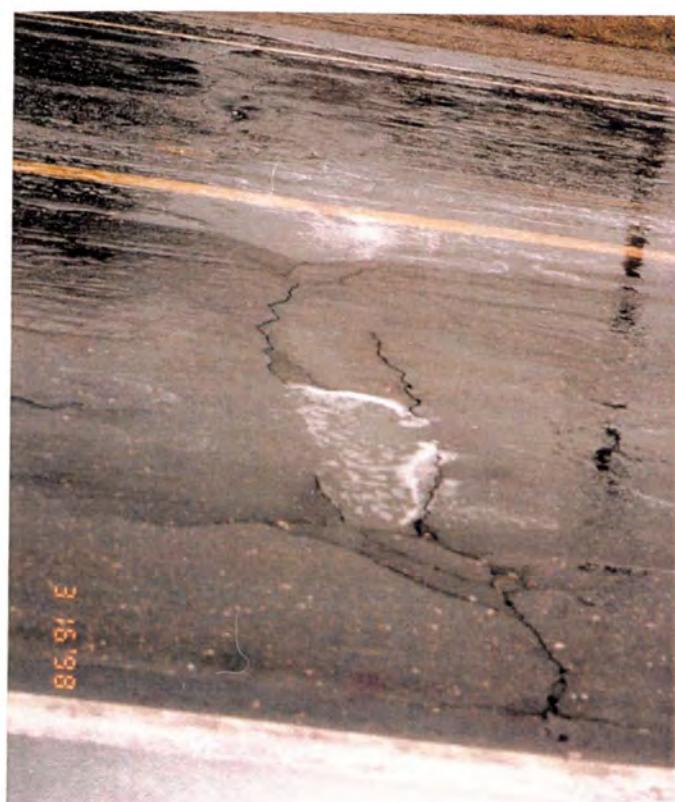
Photo #2: Ponding on the driving surface. March 16, 1998; District 2, Chariton County Route 24

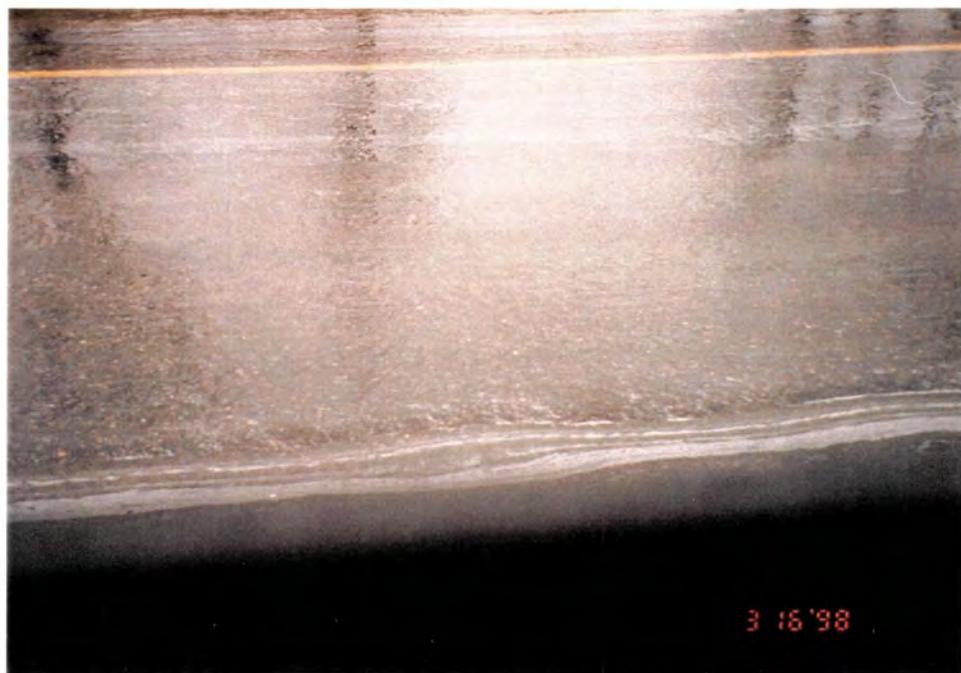
Photo #3: Narrow channel flow on the driving surface. March 16, 1998; District 2, Chariton County Route 24

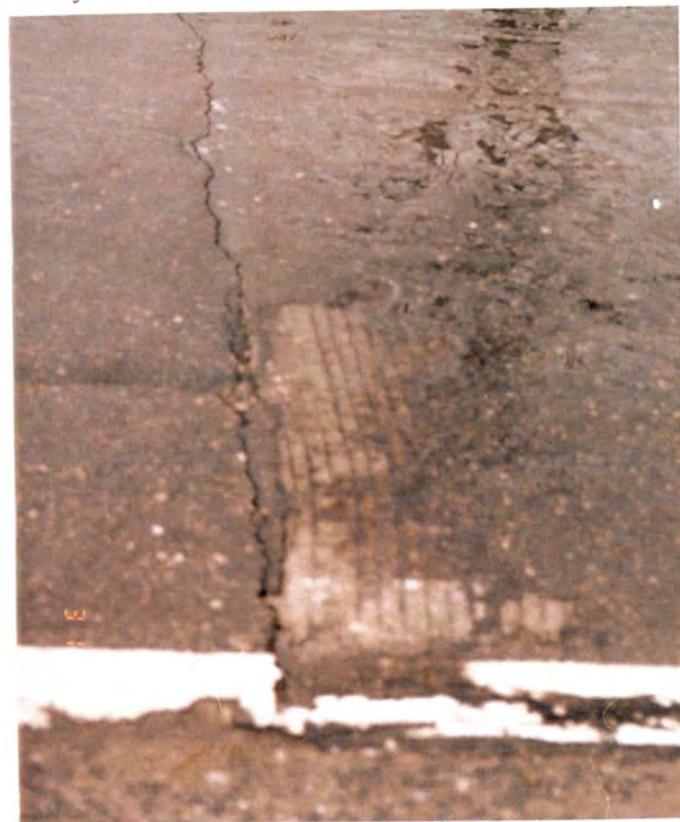
Photo #4: A concrete patch in the pavement beneath the sealant. March 16, 1998; District 2, Chariton County Route 24

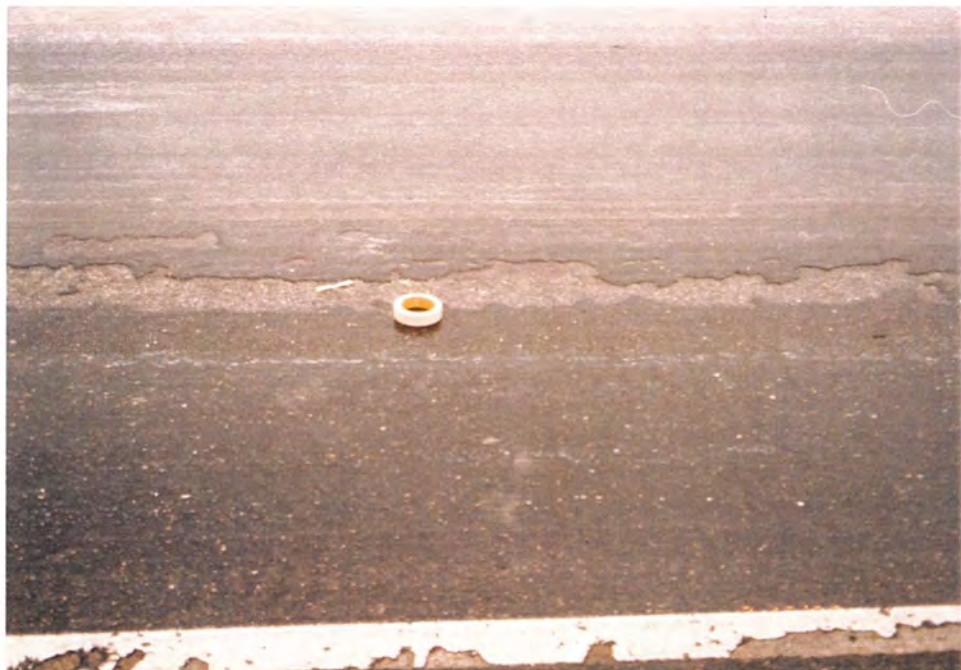
Photo #5: Loss of sealant on the driving surface. The roll of masking tape can be seen for size reference. March 16, 1998; District 2, Chariton County Route 24

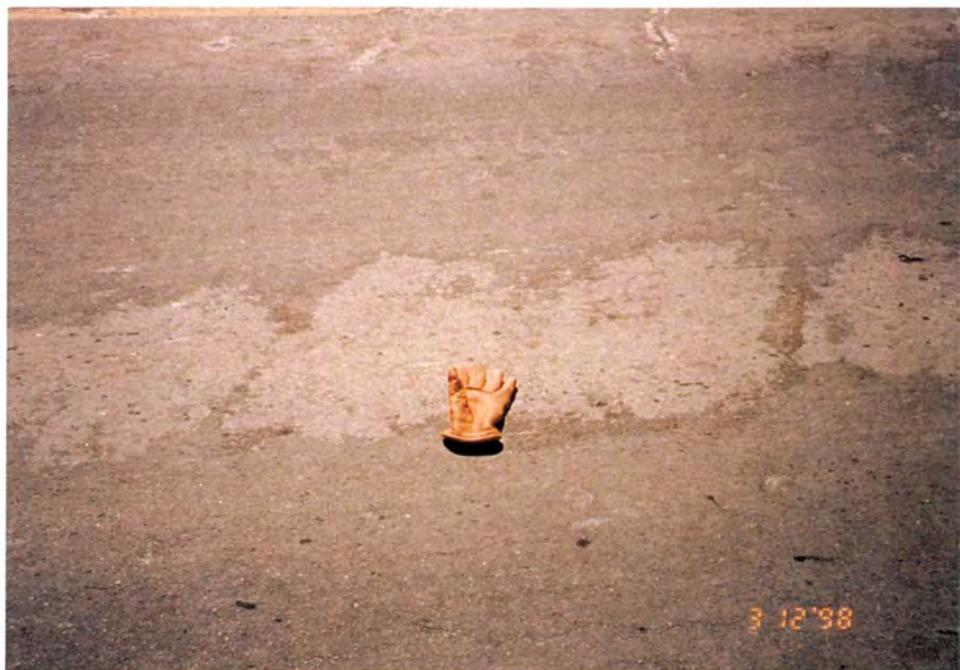
Photo #1: Loss of seal between the wheelpaths. A glove is shown for size reference.  
March 12, 1998; District 2, Randolph County Route JJ

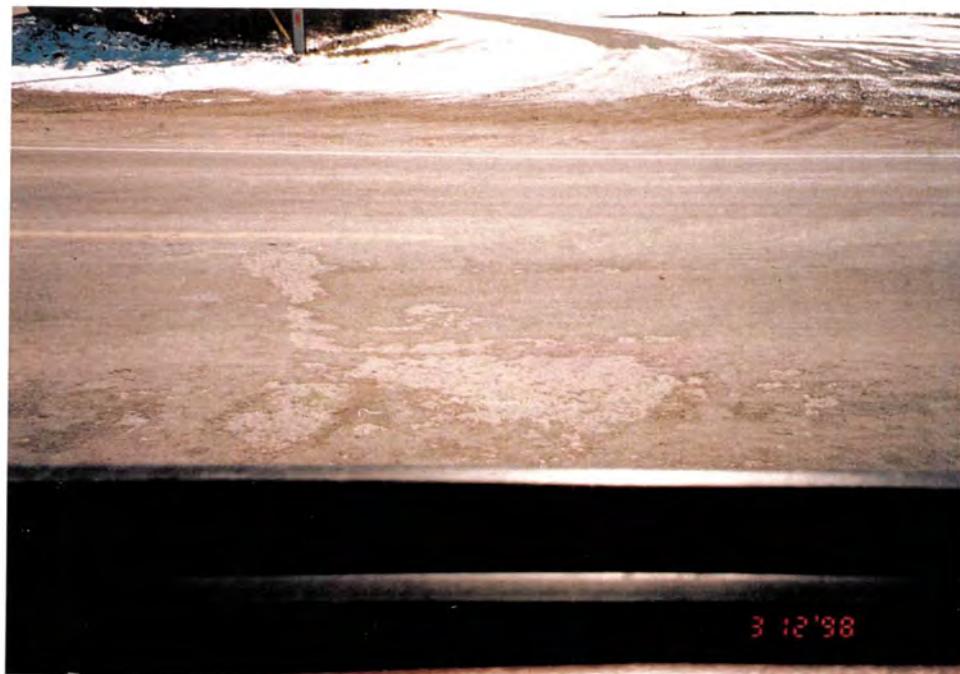
Photo #2: Loss of seal throughout the width of the lane. March 12, 1998; District 2,  
Randolph County Route JJ

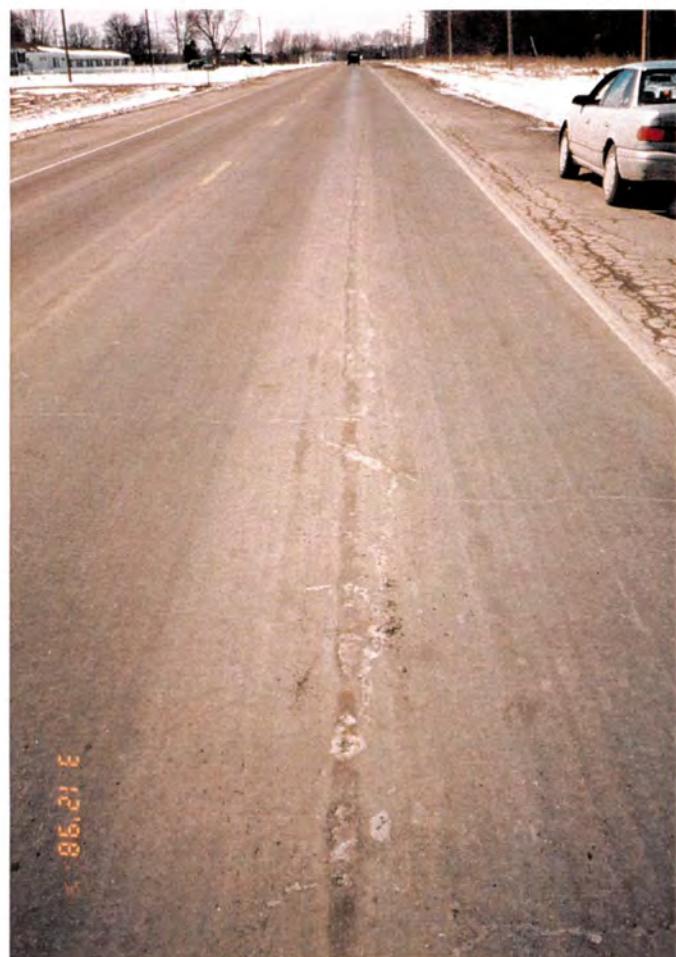
Photo #3: A series of small spalls in the seal. March 12, 1998; District 2, Randolph County Route JJ

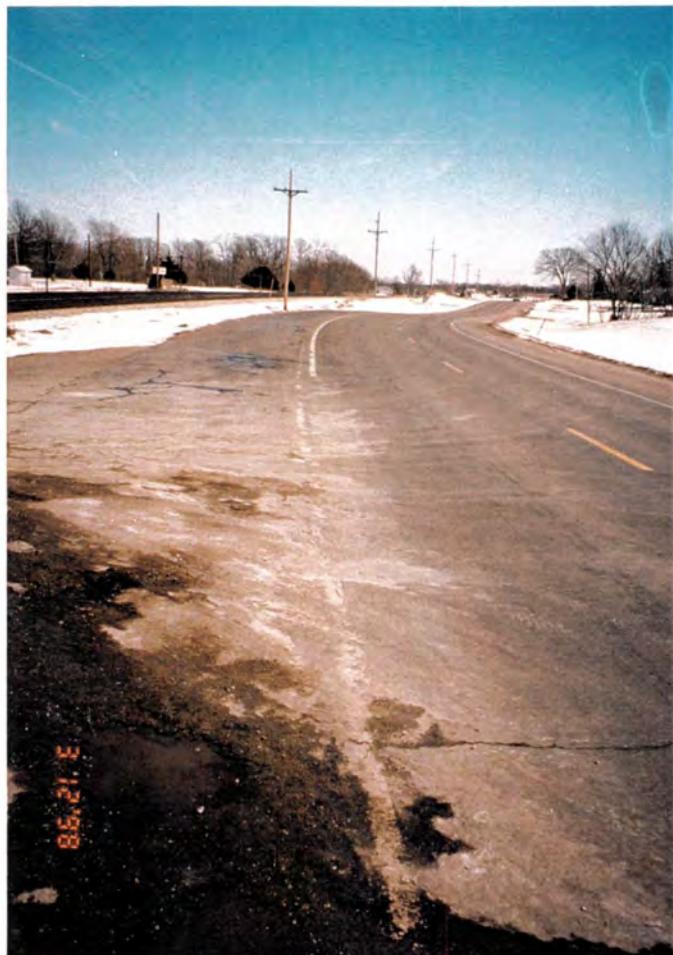
Photo #4: Loss of seal due to turning movements on a side road. March 12, 1998;  
District 2, Randolph County Route JJ

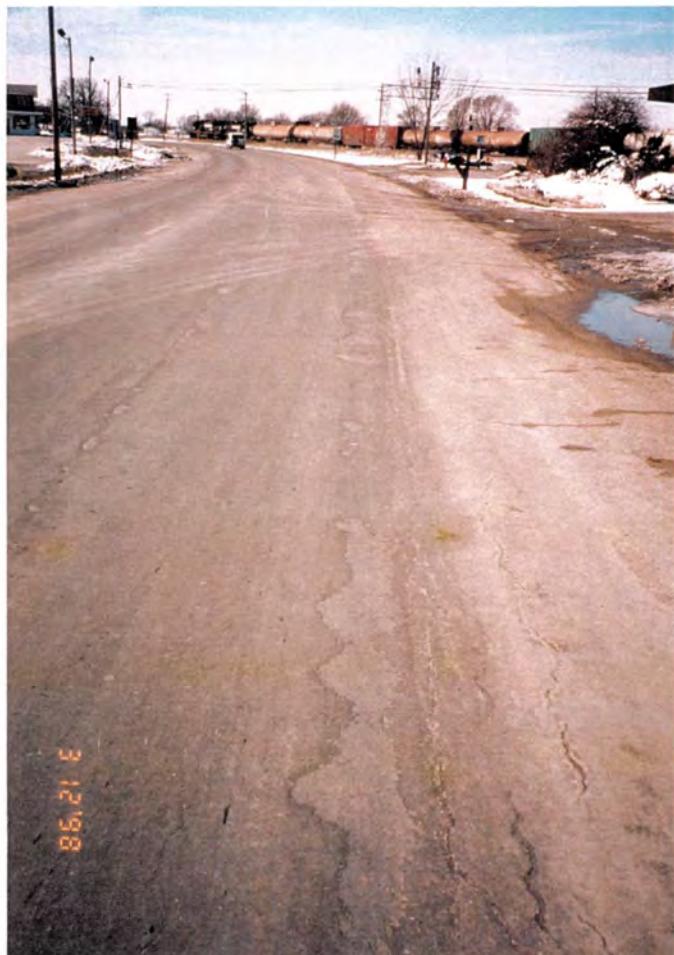
Photo #5: Loss of seal in wheelpath, near Route 24. March 12, 1998; District 2, Randolph County Route JJ

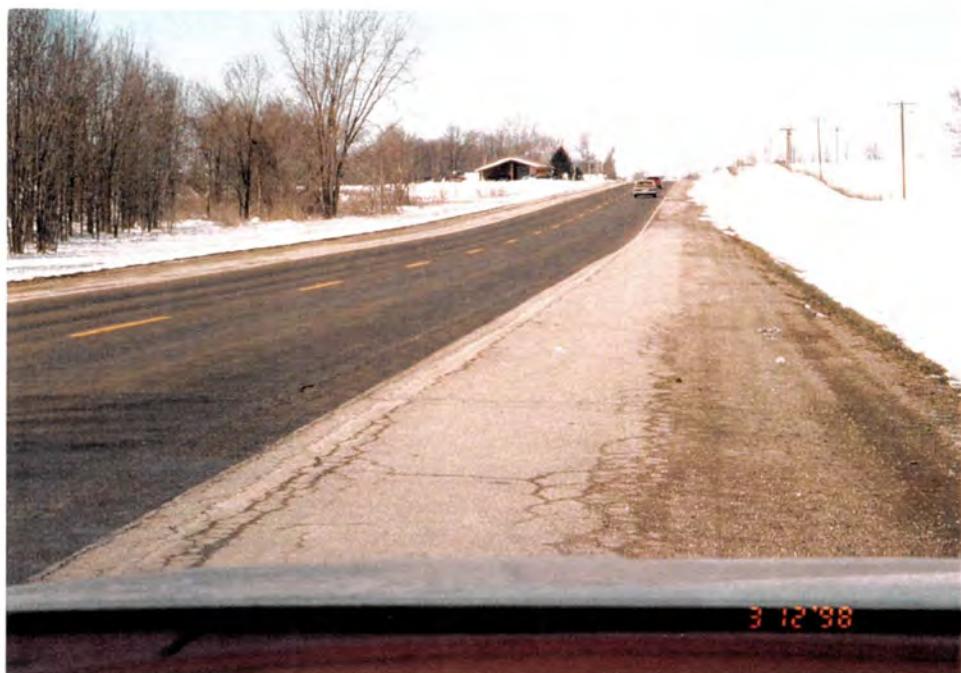
Photo #1: View of the surface from the shoulder. March 12, 1998; District 3, Audrain County Route 22

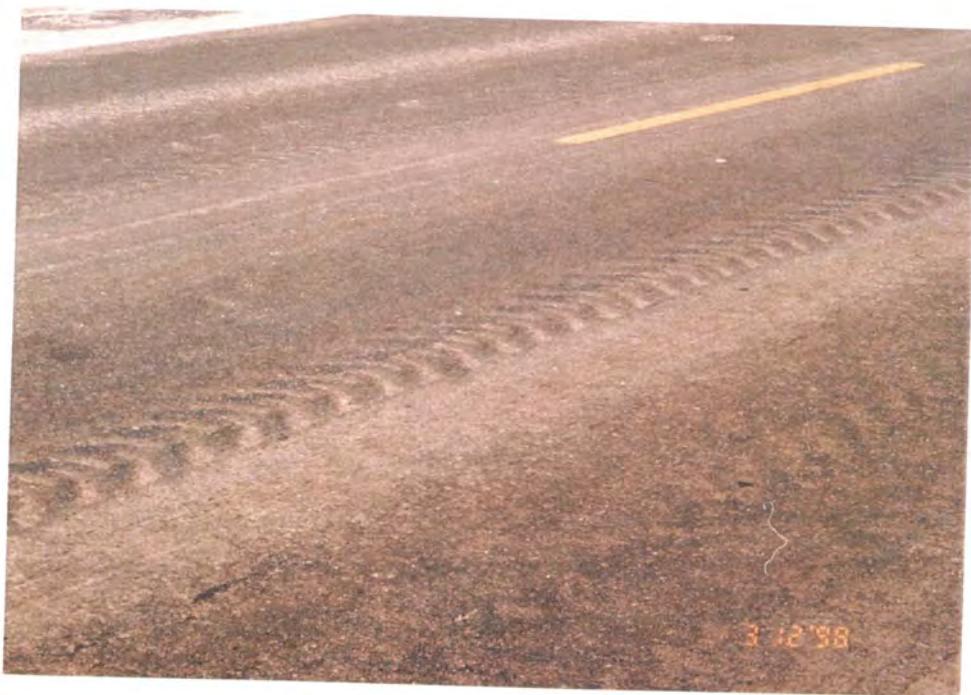
Photo #2: Grader tire marks in the surface. March 12, 1998; District 3, Audrain County Route 22

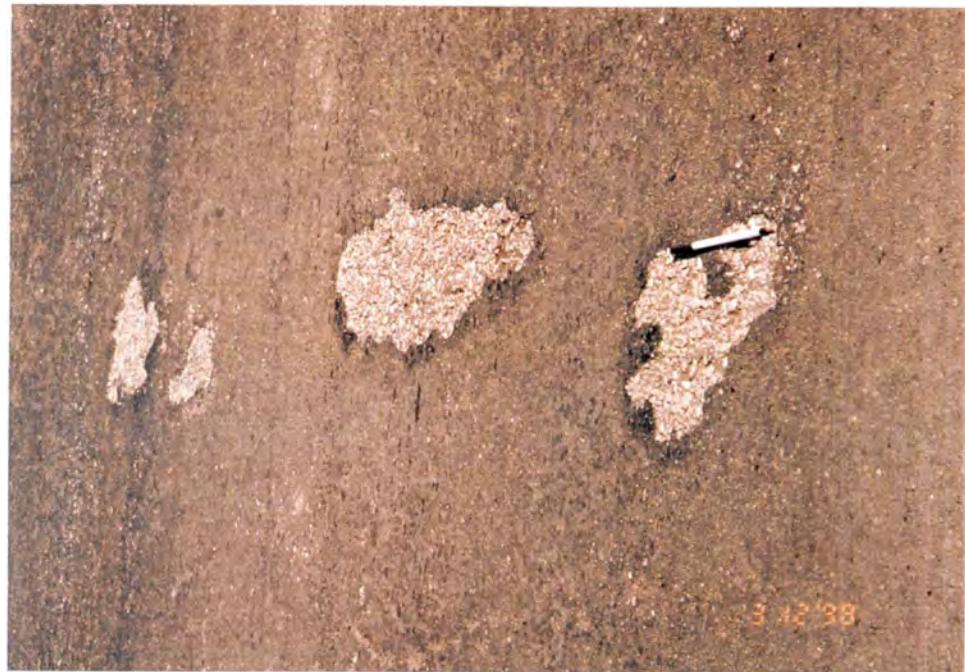
Photo # 3: A few spots having loss of sealant. An ink pen is shown for size reference.  
March 12, 1998; District 3, Audrain County Route 22

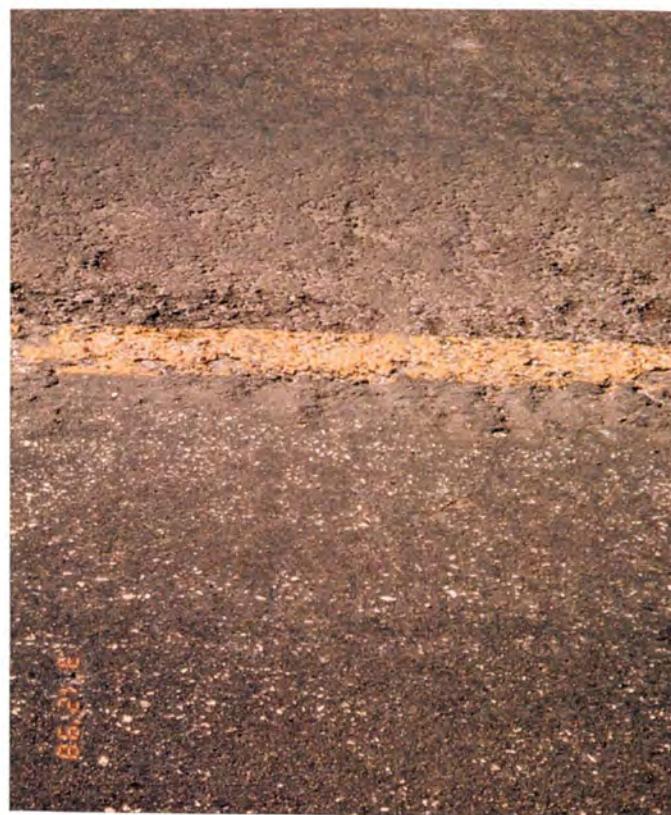
Photo #4: The inconsistent, sometimes coarse texture of the surface. March 12, 1998;  
District 3, Audrain County Route 22

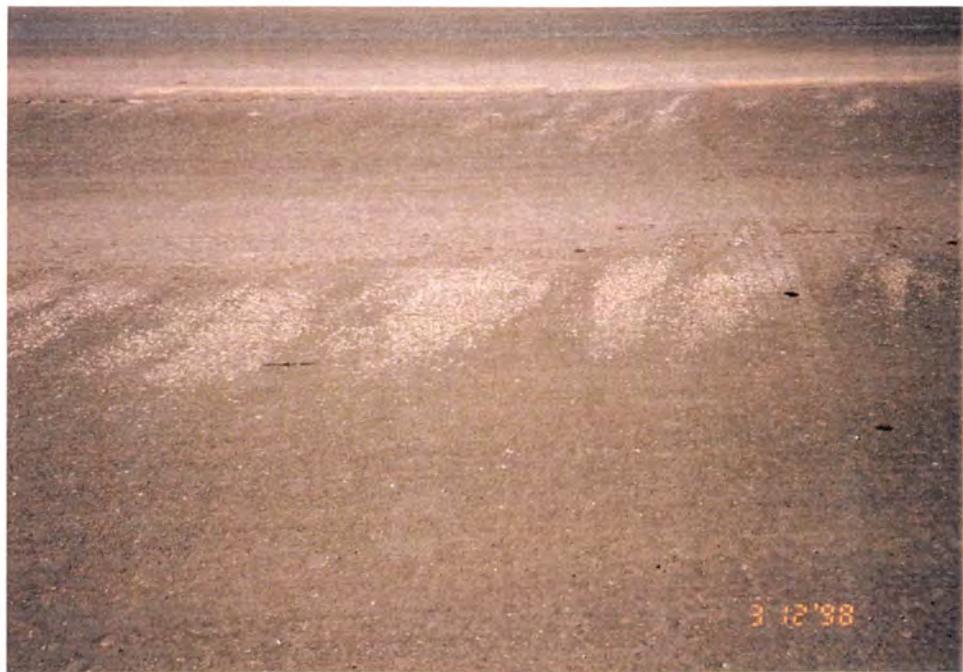
Photo #5: Snow plow damage. March 12, 1998; District 3, Audrain County Route 22

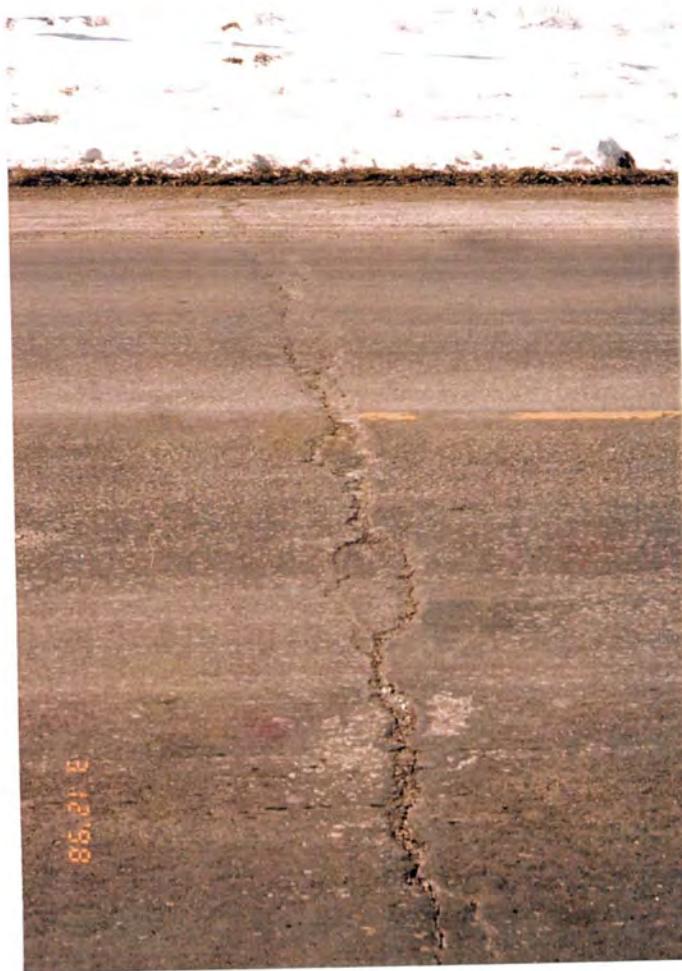
Photo #6: The sealant in a large pavement crack. March 12, 1998; District 3, Audrain County Route 22

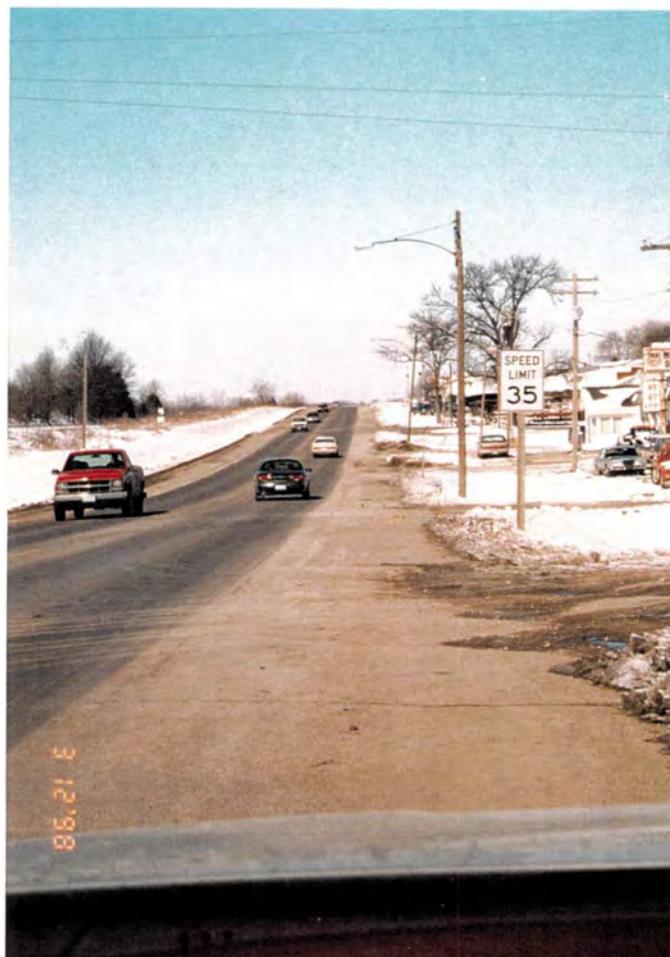
Photo #7: Another view of the surface. This seal is easily identified in this location due to its very black color. March 12, 1998; District 3, Audrain County Route 22

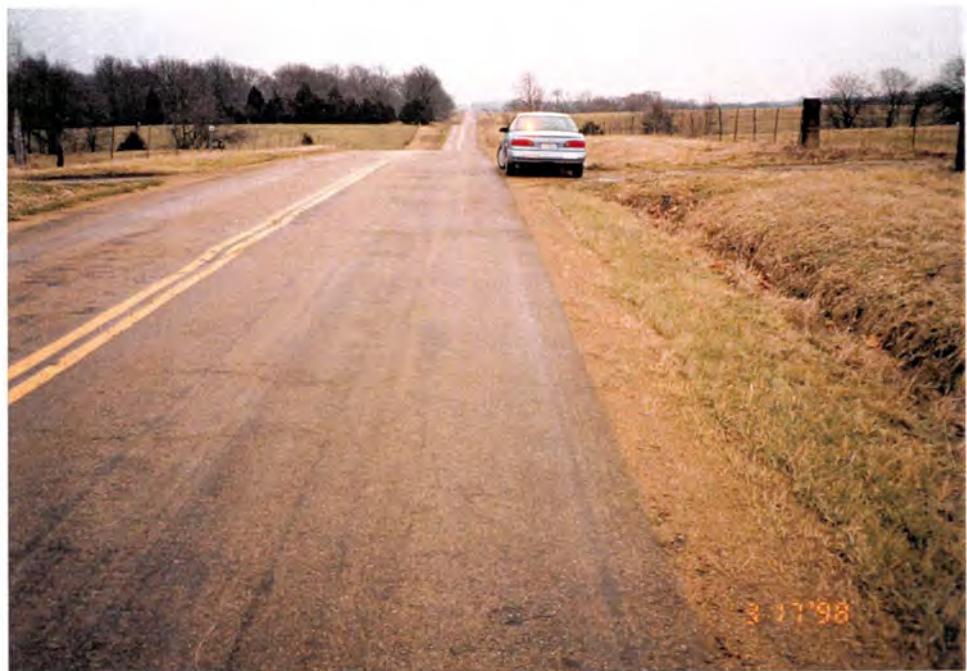
Photo #1: A view of the driving surface. March 17, 1998; District 4, Henry County Route H

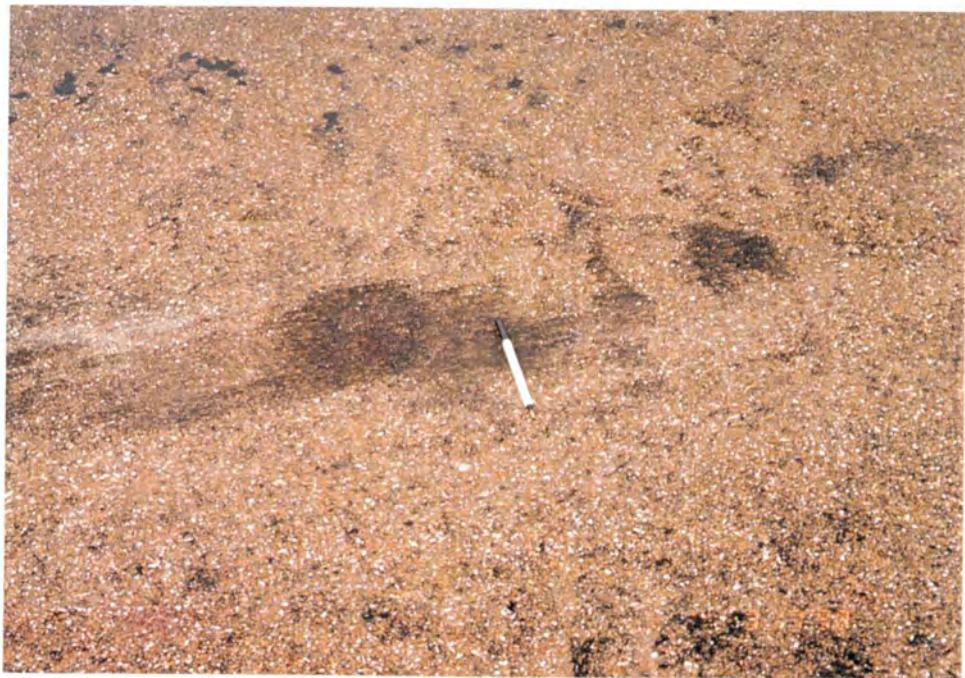
Photo #2: A close-up view of the surface, showing a mild snowplow scar. An inkpen is shown for size reference. March 17, 1998; District 4, Henry County Route H

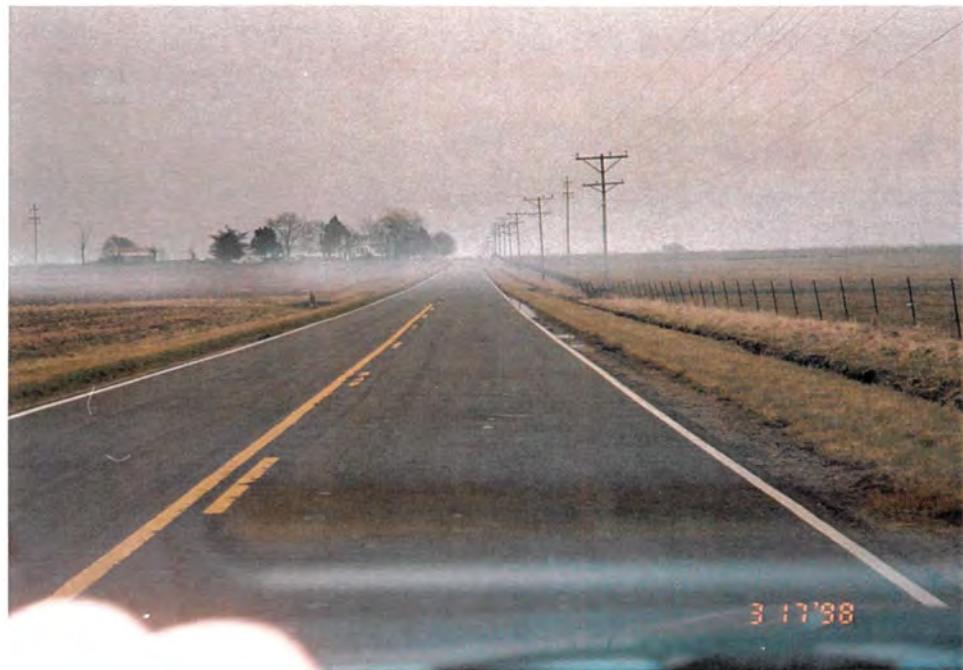
Photo #1: A view of the driving surface. March 17, 1998; District 4, Henry County Route 52

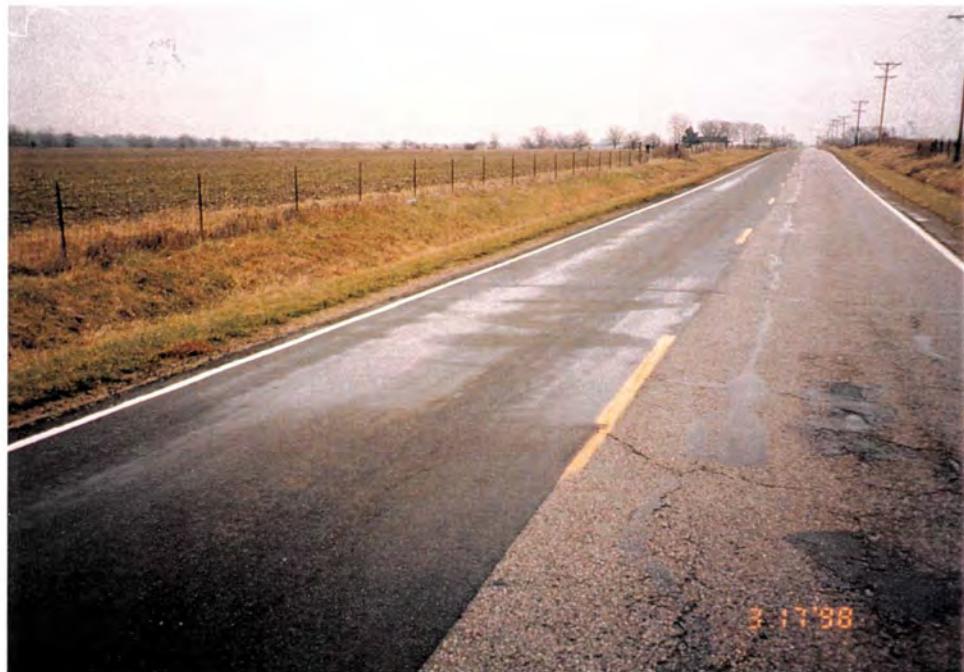
Photo #2: The lane on the left has been sealed; the one on the right has not. The seal appears to make a distinct difference in the quality of the driving surface. March 17, 1998; District 4, Henry County Route 52

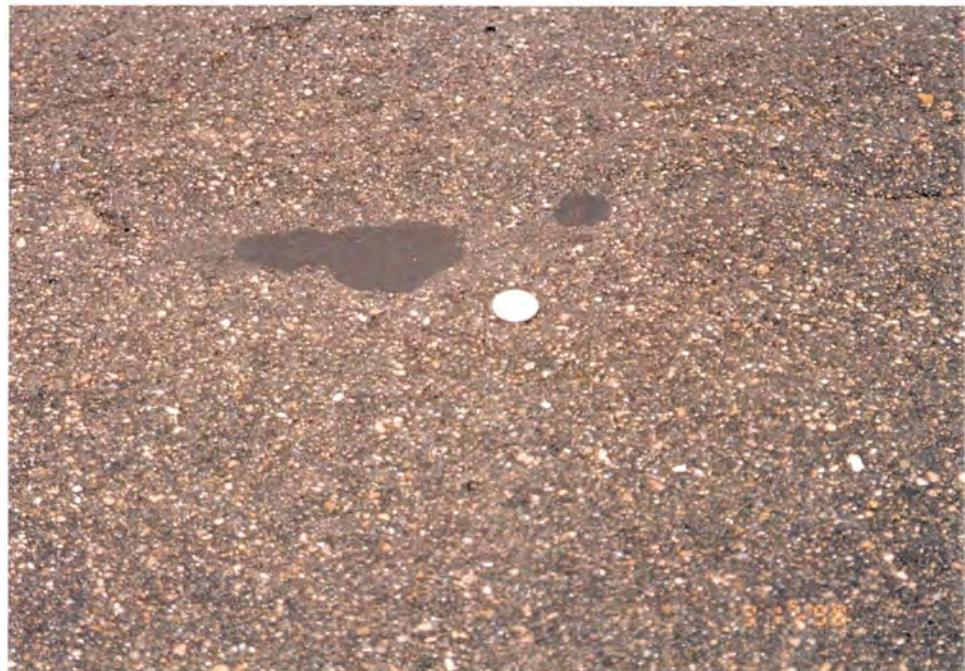
Photo #3: Splotches of emulsion on the surface. A quarter is shown for size reference.  
March 17, 1998; District 4, Henry County Route 52
