**MoDOT**

Product Development 96-004

# Scrub Seal

Initial Report

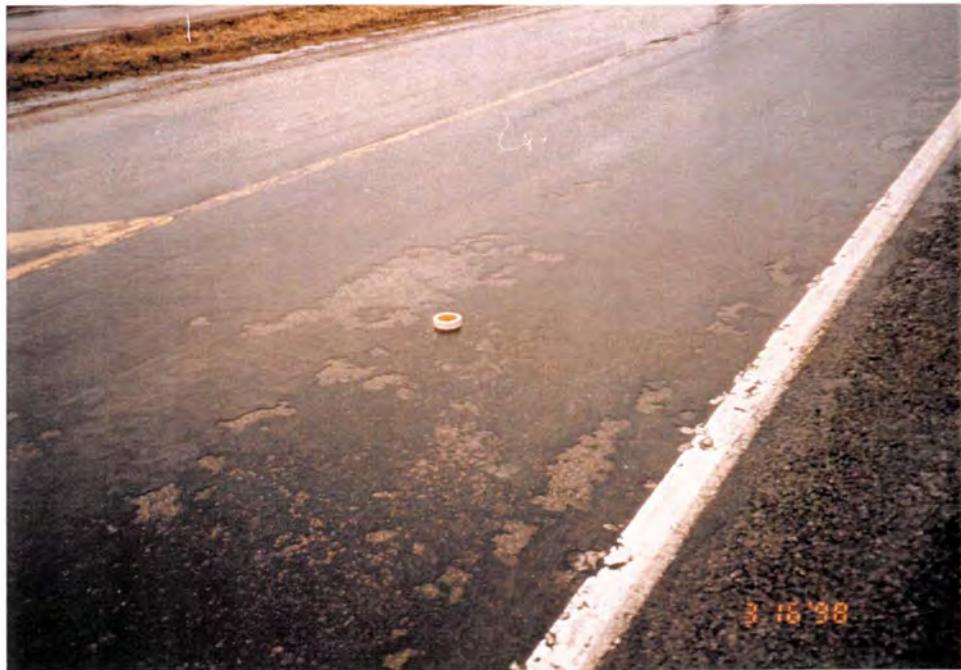
Photo #1: Wear and loss of seal on the surface. The roll of masking tape can be seen for size reference. March 16, 1998; District 4, Lafayette County Route 24

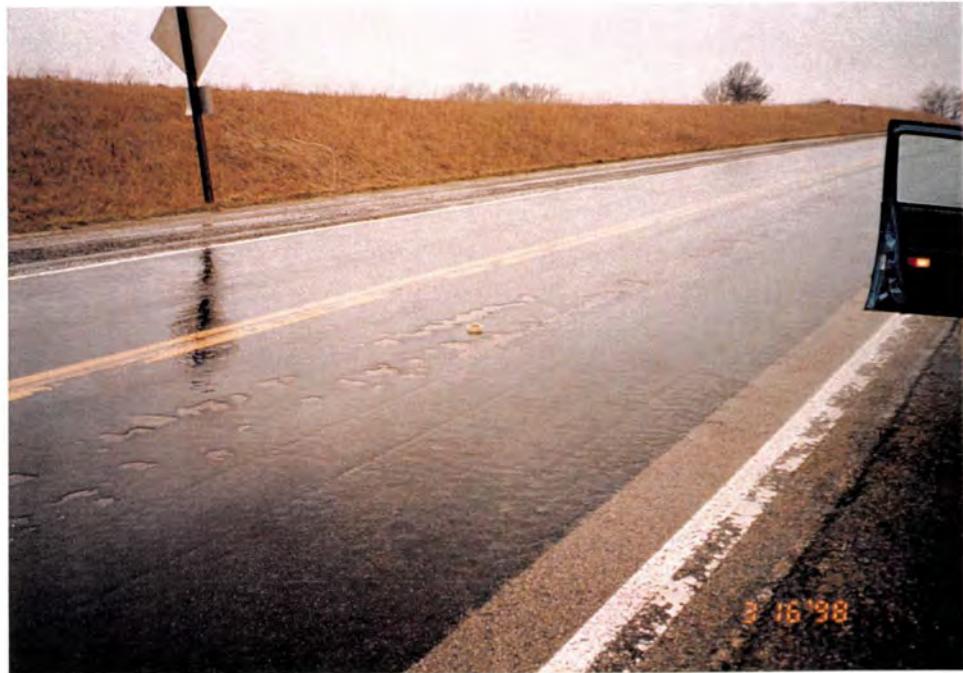
Photo #2: More wear and loss of seal. The masking tape can be seen for size reference. In the vicinity of the car door, it can be seen where the seal was applied in such a fashion that the entire width of the lane was not covered. March 16, 1998; District 4, Lafayette County Route 24

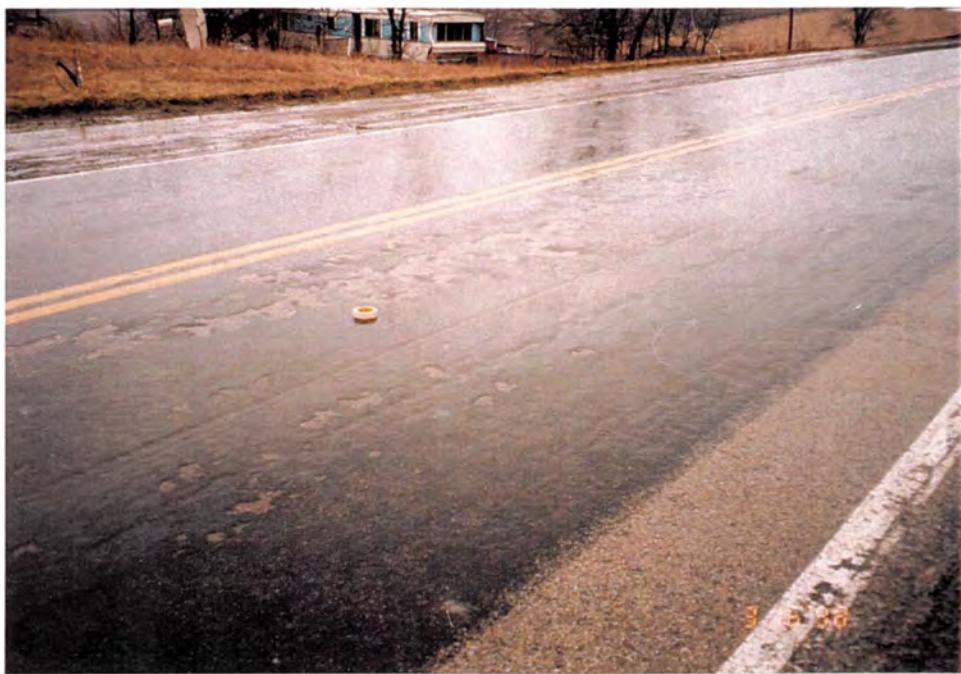
Photo #3: A closer view of picture #2. March 16, 1998; District 4, Lafayette County Route 24

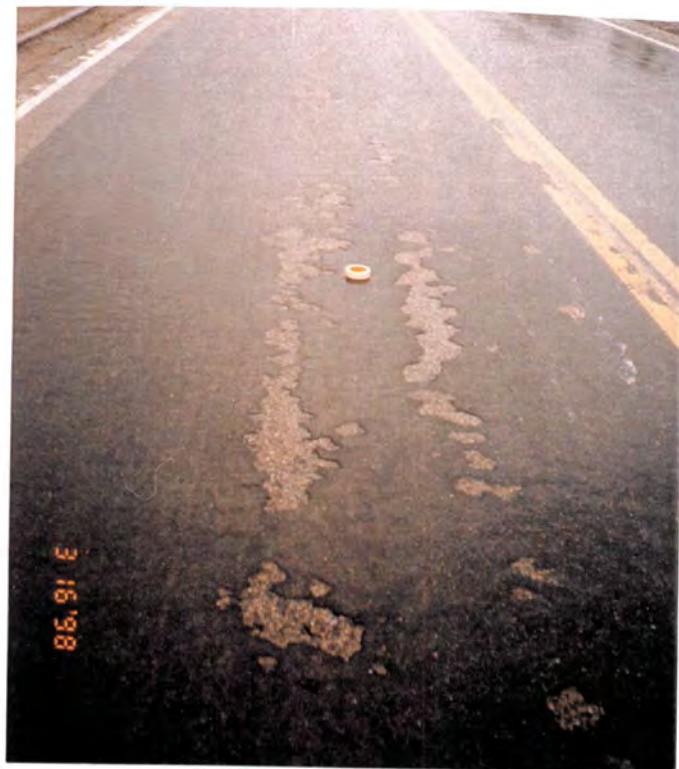
Photo #4: More wear and loss of seal. The masking tape can be seen for size reference. March 16, 1998; District 4, Lafayette County Route 24

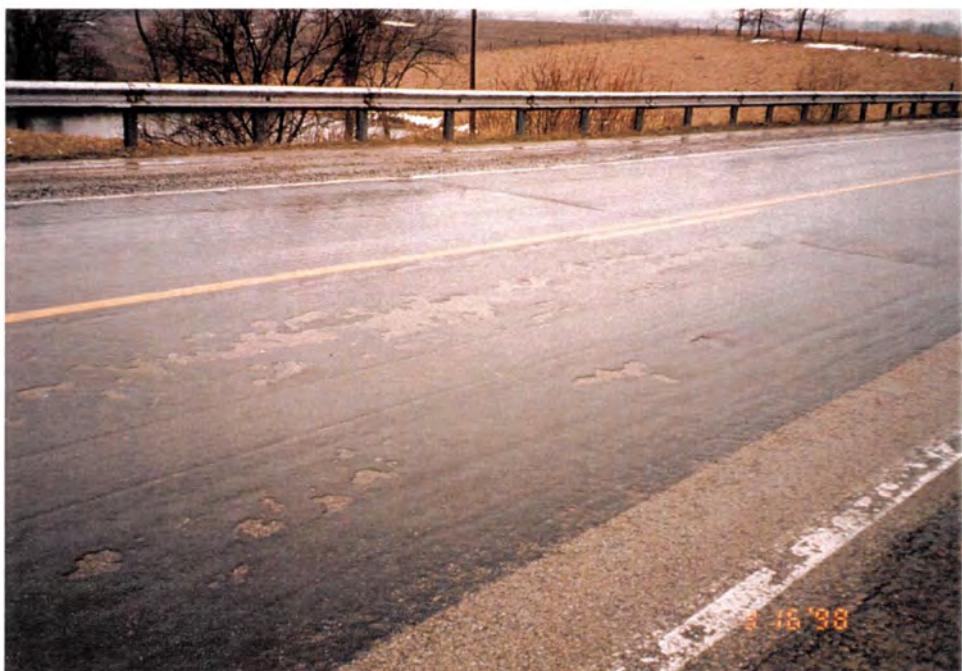
Photo #5: Still more wear and loss of seal. March 16, 1998; District 4, Lafayette County Route 24

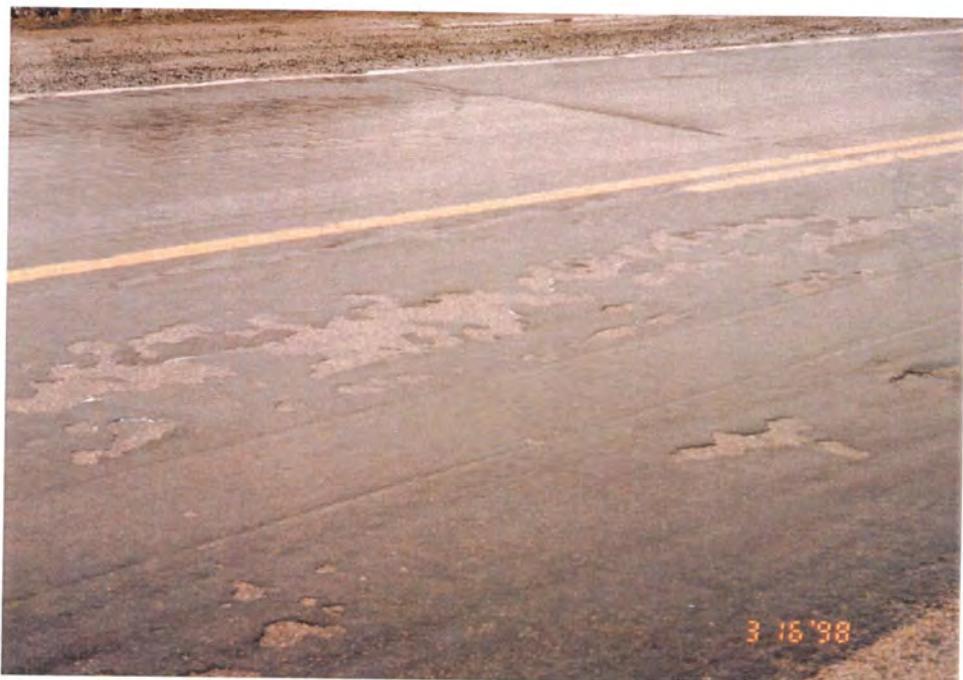
Photo #6: A close-up view of Photo #5. March 16, 1998; District 4, Lafayette County Route 24

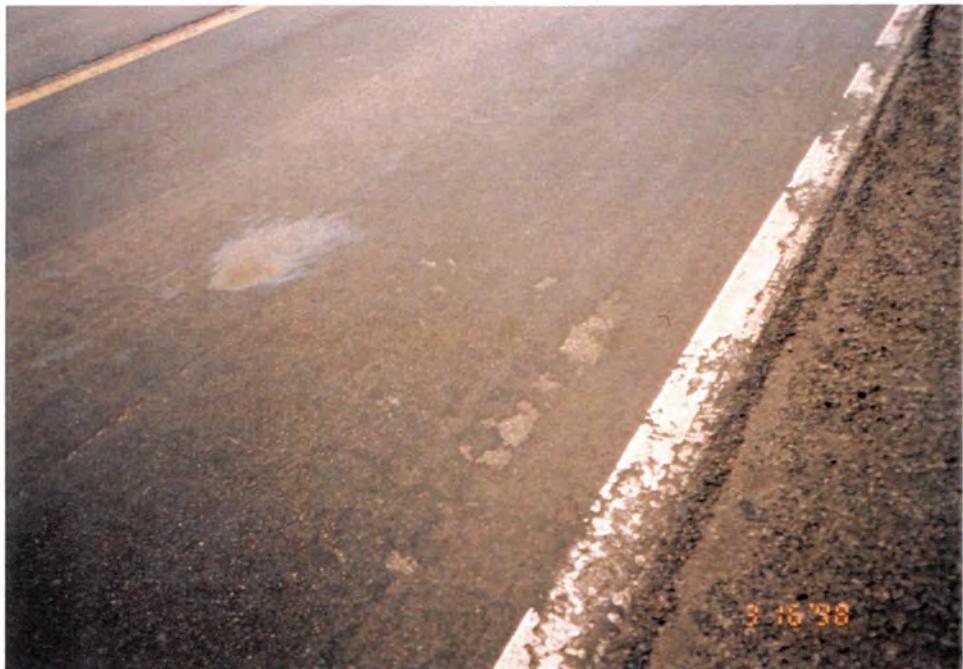
Photo #7: The rainbow colored splotch reported on in the locational synopsis. A small area of sealant loss can also be seen. March 16, 1998; District 4, Lafayette County Route 24

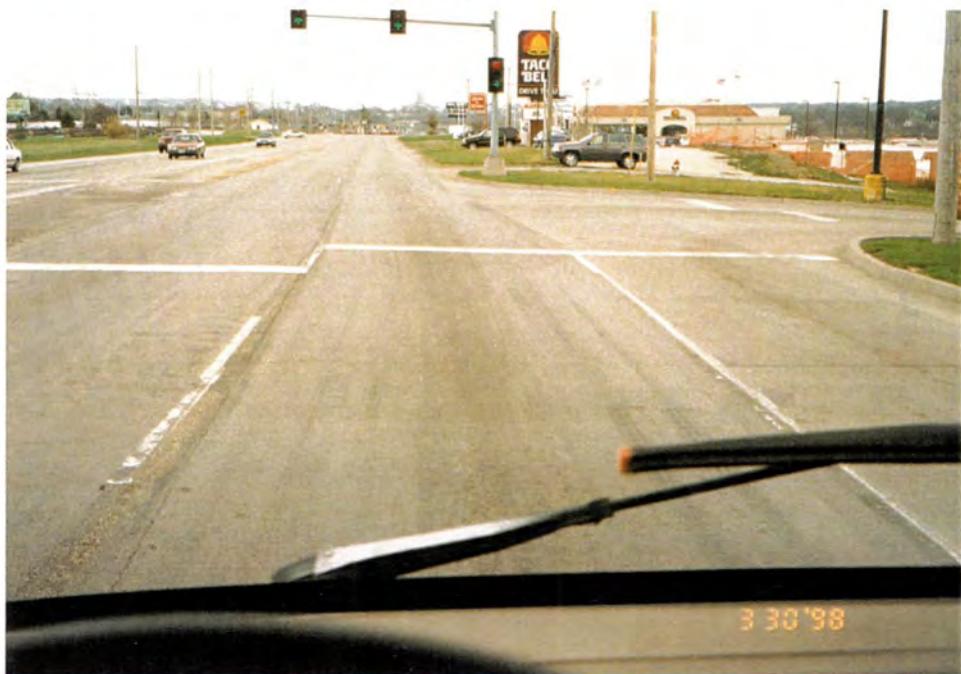
Photo #1: A view of the surface at the turnoff to Wal-Mart. March 30, 1998; District 5, Cole County Business Route 50 (Missouri Boulevard)

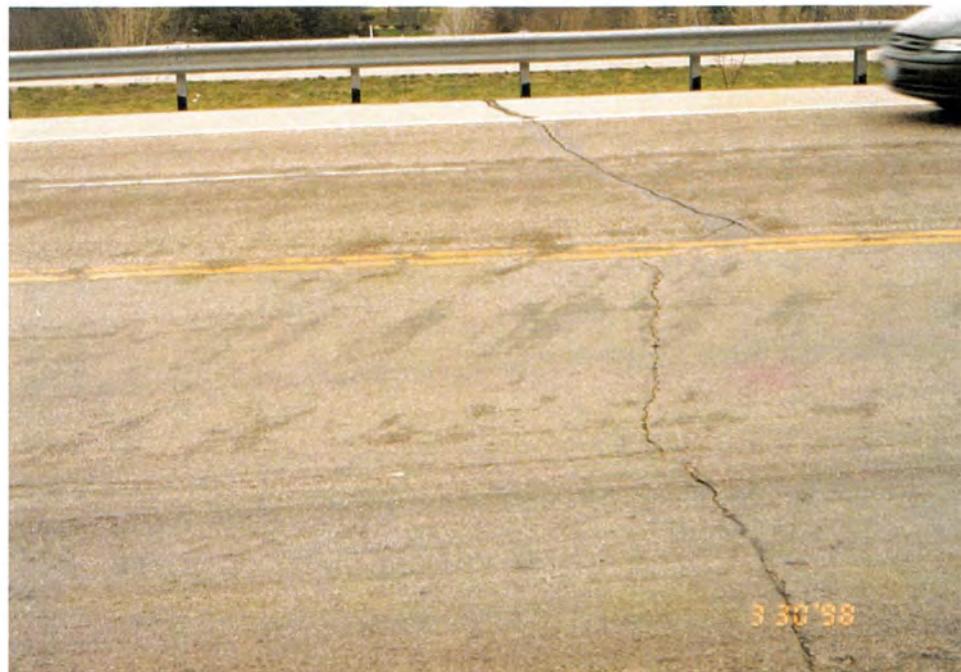
Photo #2: A view of the seal lane (closest) and the unsealed lane. March 30, 1998; District 5, Cole County Business Route 50 (Missouri Boulevard)

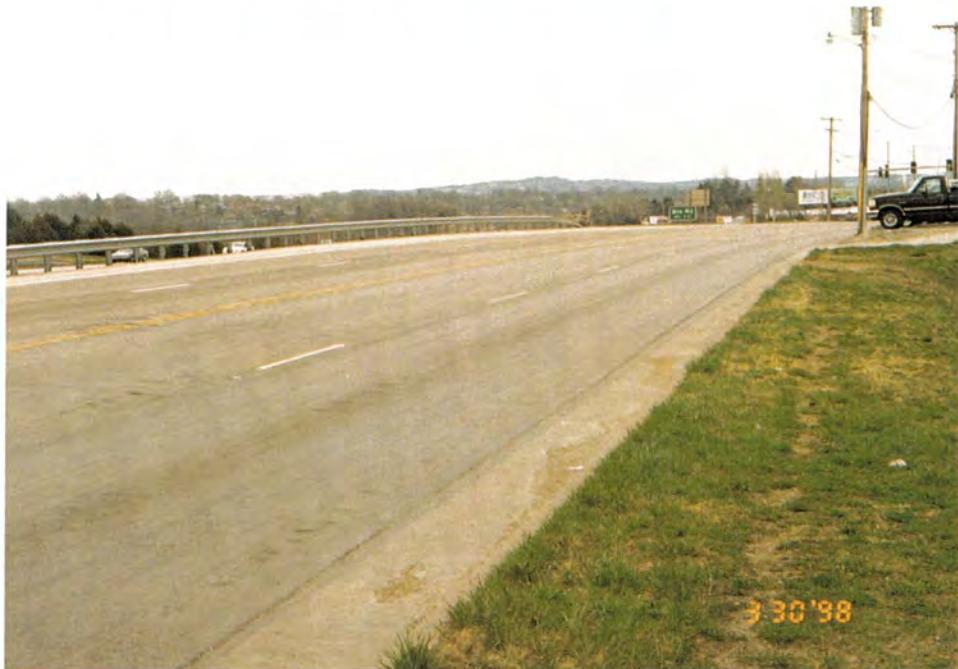
Photo #3: A view of the surface from the west end of the project. March 30, 1998; District 5, Cole County Business Route 50 (Missouri Boulevard)

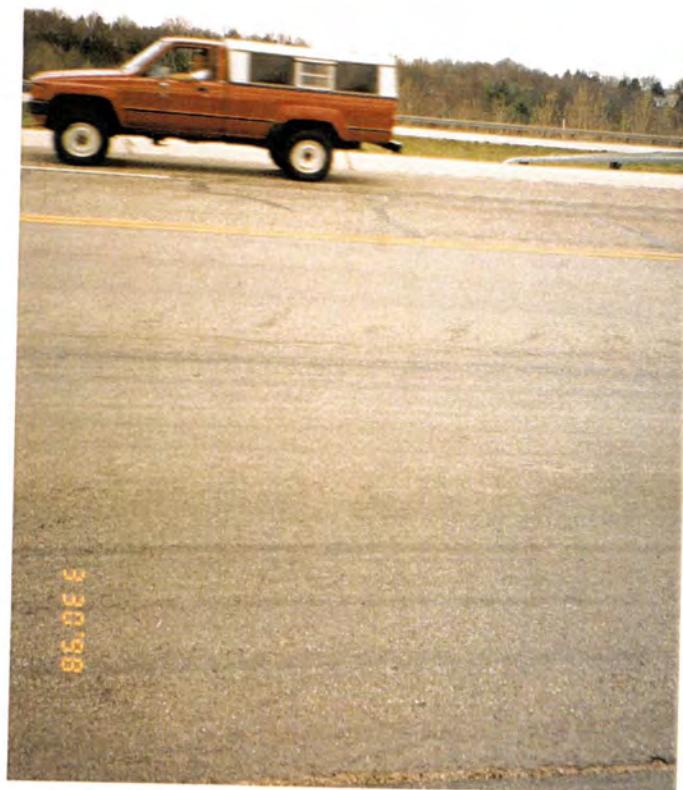
Photo #4: Another view of the surface. March 30, 1998; District 5, Cole County Business Route 50 (Missouri Boulevard)

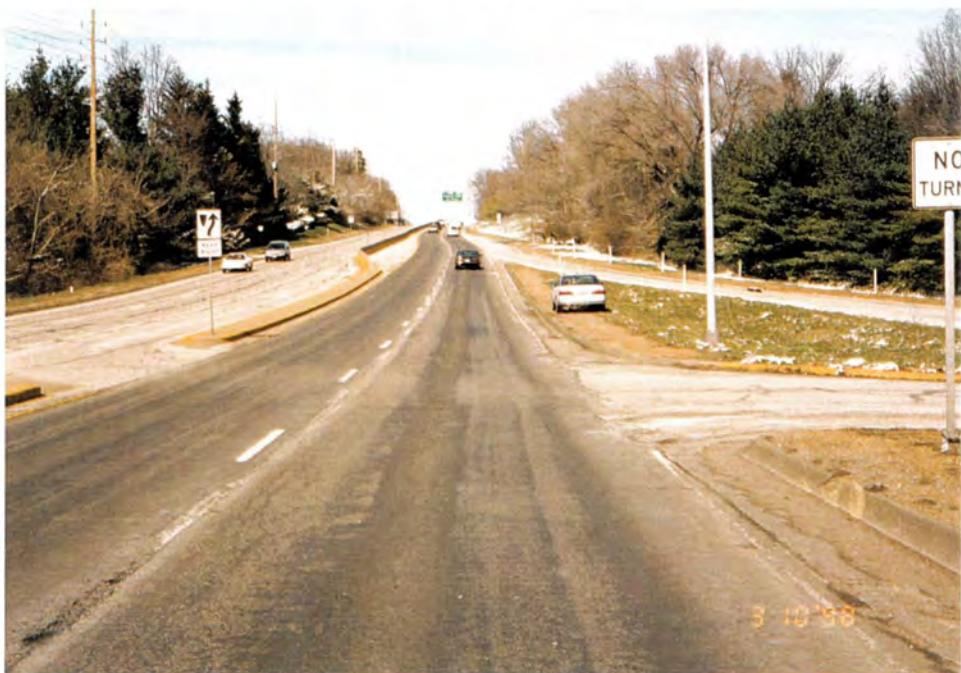
Photo #1: View up the hill leading to the Frontenac city limits. The seal is almost gone in the wheelpaths. March 10, 1998; District 6, St. Louis County Route 67 (Lindbergh Boulevard)

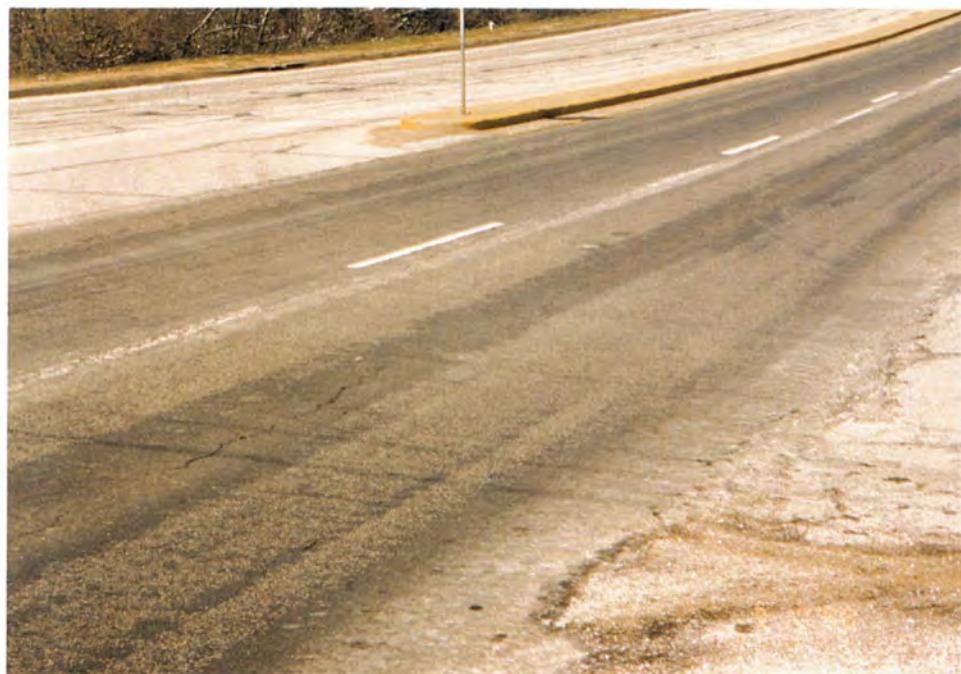
Photo #2: A close-up of the wheelpaths in this location. March 10, 1998; District 6, St. Louis County Route 67 (Lindbergh Boulevard)

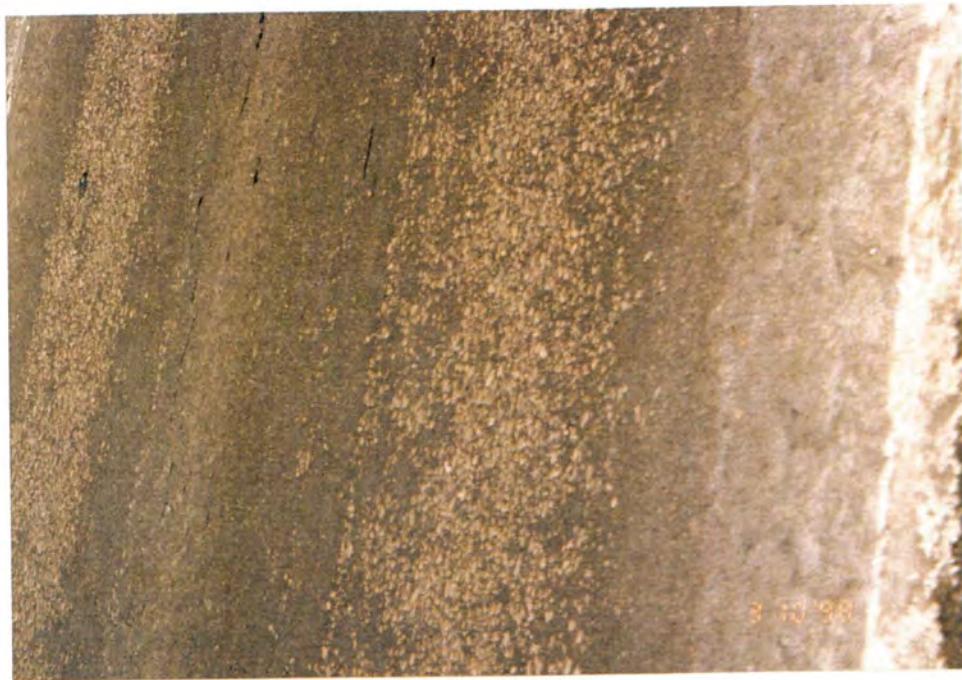
Photo #3: A closer view of the wheelpath from Photo #2. The seal is very worn. March 10, 1998; District 6, St. Louis County Route 67 (Lindbergh Boulevard)

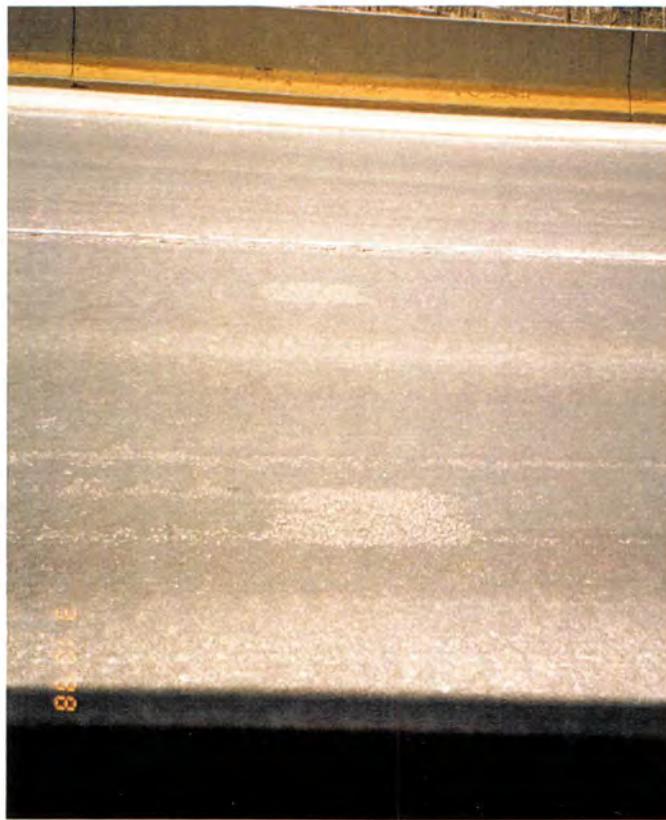
Photo #4: Two squares approximately 2' x 1.5' that has no seal. Several such areas were noticed on the south end of the project. March 10, 1998; District 6, St. Louis County Route 67 (Lindbergh Boulevard)

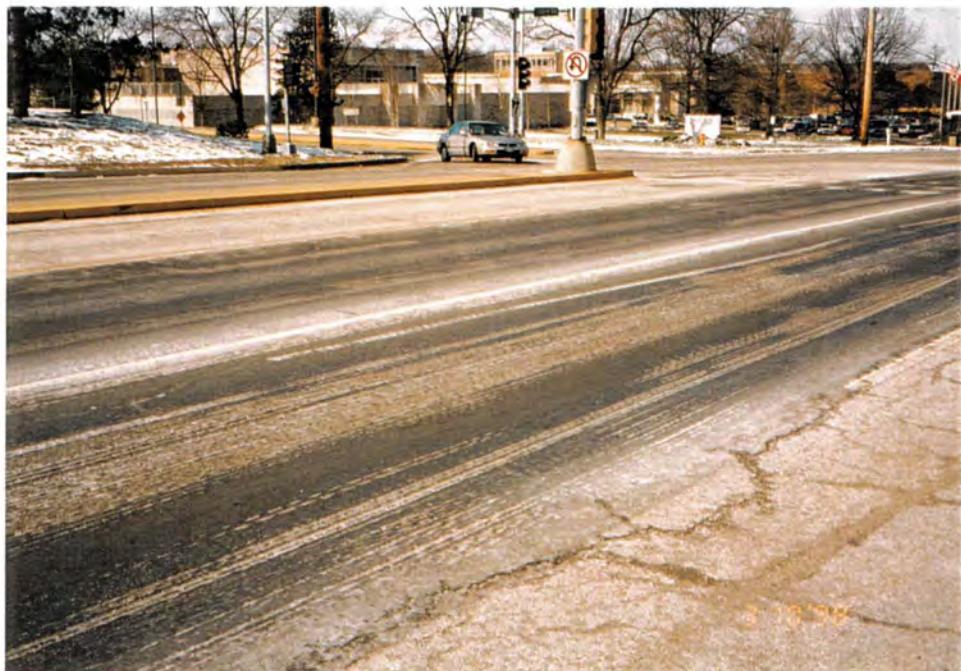
Photo #5: Coldmilling that has been performed at Litzsinger Road. March 10, 1998; District 6, St. Louis County Route 67 (Lindbergh Boulevard)

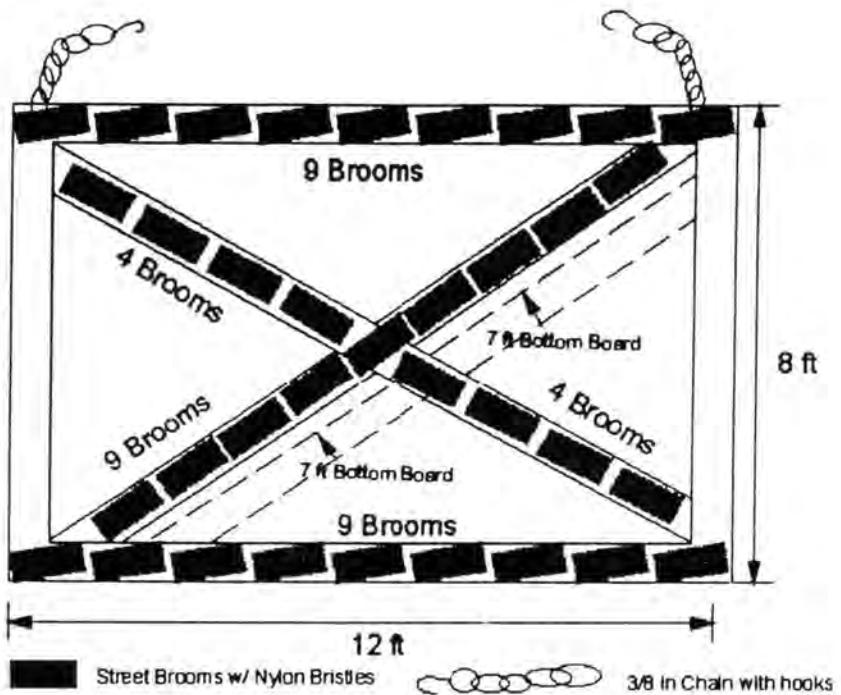
Figure 1

The final assembly shall be constructed with the nominal dimensions and the arrangement shown in the figure 1.
