DOT/FAA/AR-97/65

Stabilized Base Courses for Advanced Pavement Design Report 1: Literature Review and Field Performance Data

September 1999

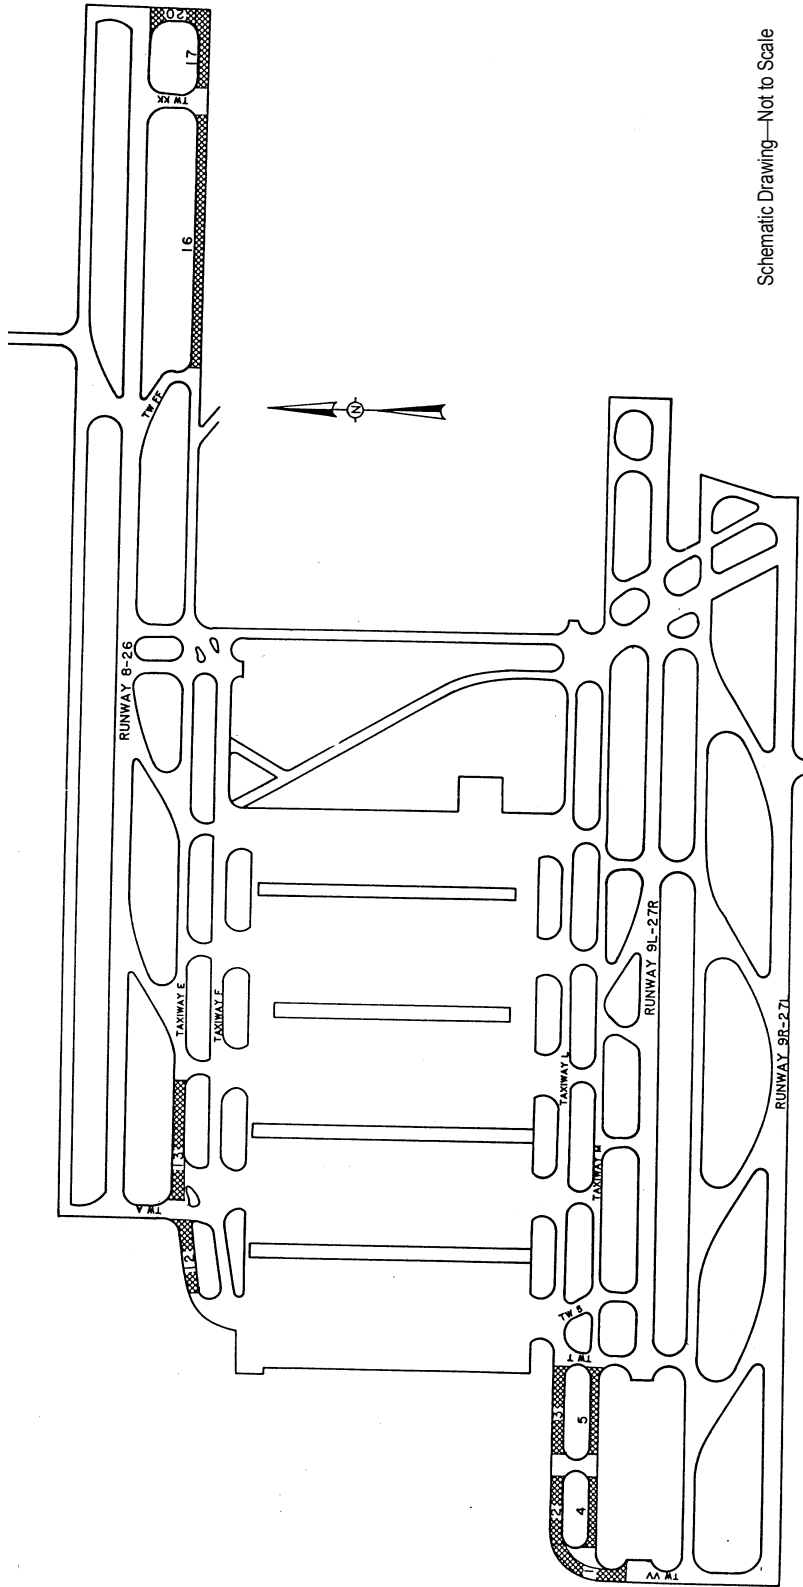
FIGURE C-1. LAYOUT OF ATLANTA INTERNATIONAL AIRPORT

Schematic Drawing—Not to Scale

The pavements evaluated at ATL were constructed in 1979 and were in service for 16 years at the time of this study. The pavements were designed for a 20-year design life. All the pavements evaluated at ATL are rigid pavements with approximately 0.06 percent temperature steel. The slabs in the pavements evaluated were a nominal 41 cm (16 in.) thick with transverse joint spacings of 7.5 m (25 ft). The longitudinal joints were keyed. It should be noted that a conclusion of the high traffic volume study indicated that keyed joints in highly channelized areas subjected to high traffic volumes should be limited, even when placed on strong subgrades.

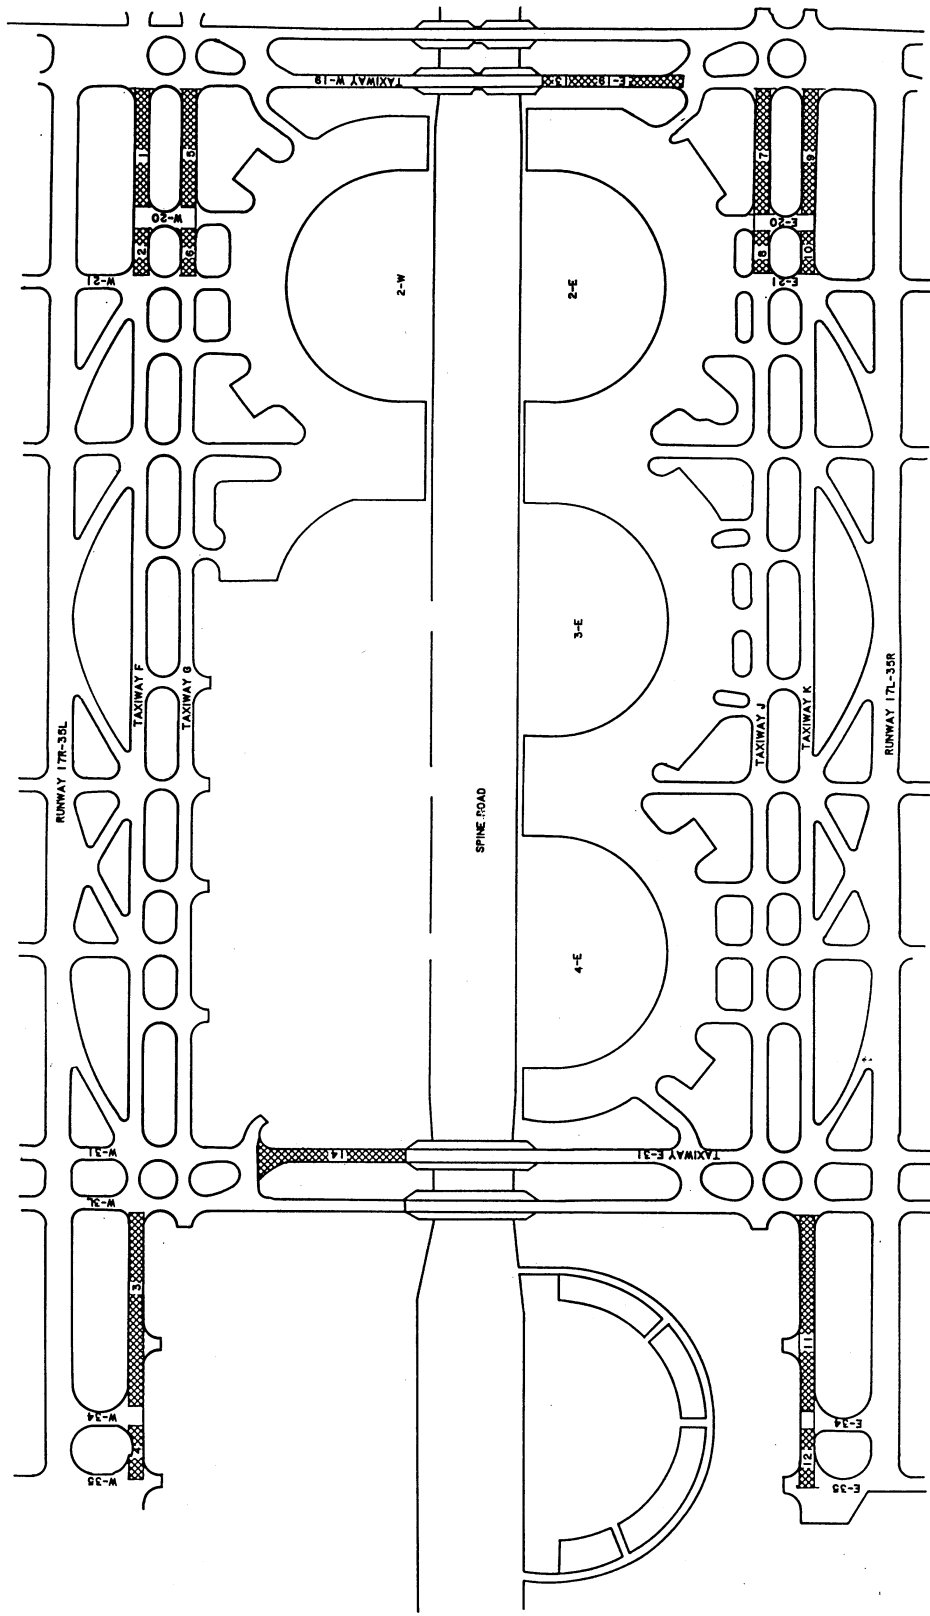
FIGURE C-2. LAYOUT OF DALLAS/FORT WORTH INTERNATIONAL AIRPORT

Schematic Drawing—Not to Scale

Dallas/Fort Worth (DFW) was opened to aircraft traffic in 1974. Therefore, at the time of this study the pavements were approximately 21 years old, 1 year older than their design life. The pavements are all rigid, designed as jointed reinforced-concrete slabs. The original design called for doweled joints spaced at 15-m (50-ft) intervals. After construction commenced, the design was changed due to regular cracking being observed at approximately 7.5-m (25-ft) spacings (mid-slab). The remaining pavements were constructed with doweled joints at 15-m (50-ft) spacings and contraction joints were sawed at 7.5-m (25-ft) spacings. The longitudinal joints were drilled and epoxy doweled. The slabs contained approximately 0.07 percent temperature

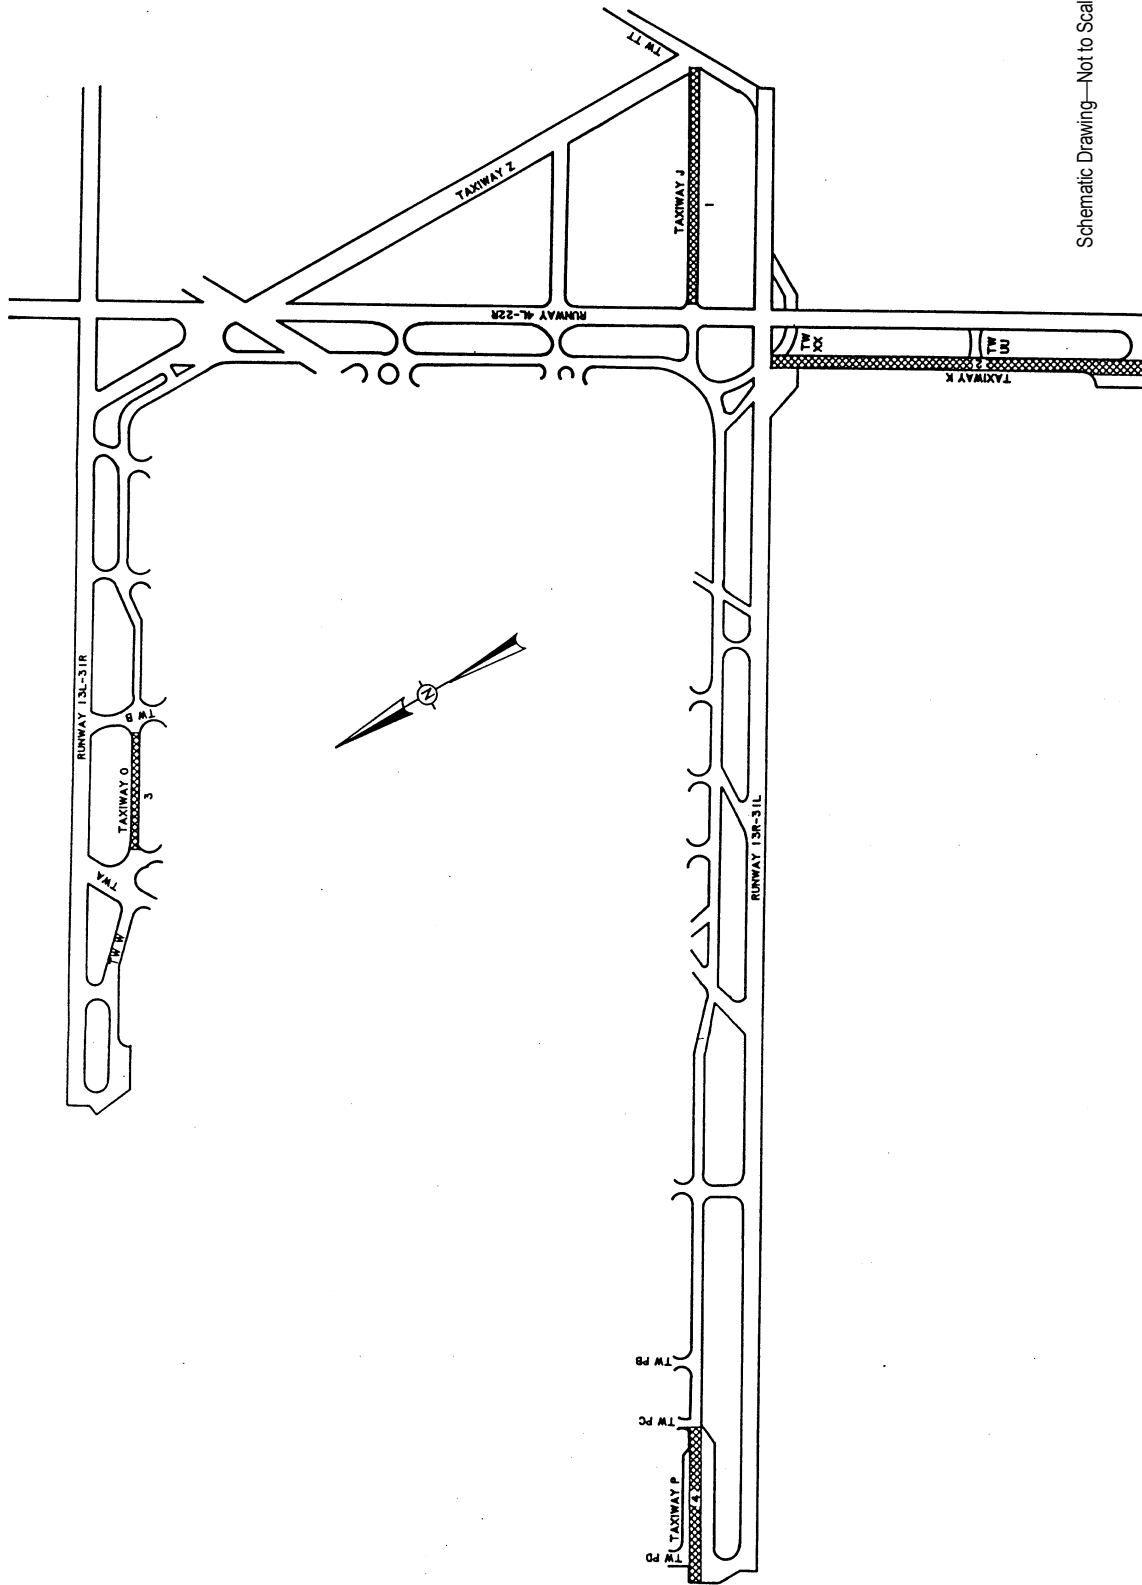
FIGURE C-3. LAYOUT OF JOHN F. KENNEDY INTERNATIONAL AIRPORT

Schematic Drawing—Not to Scale

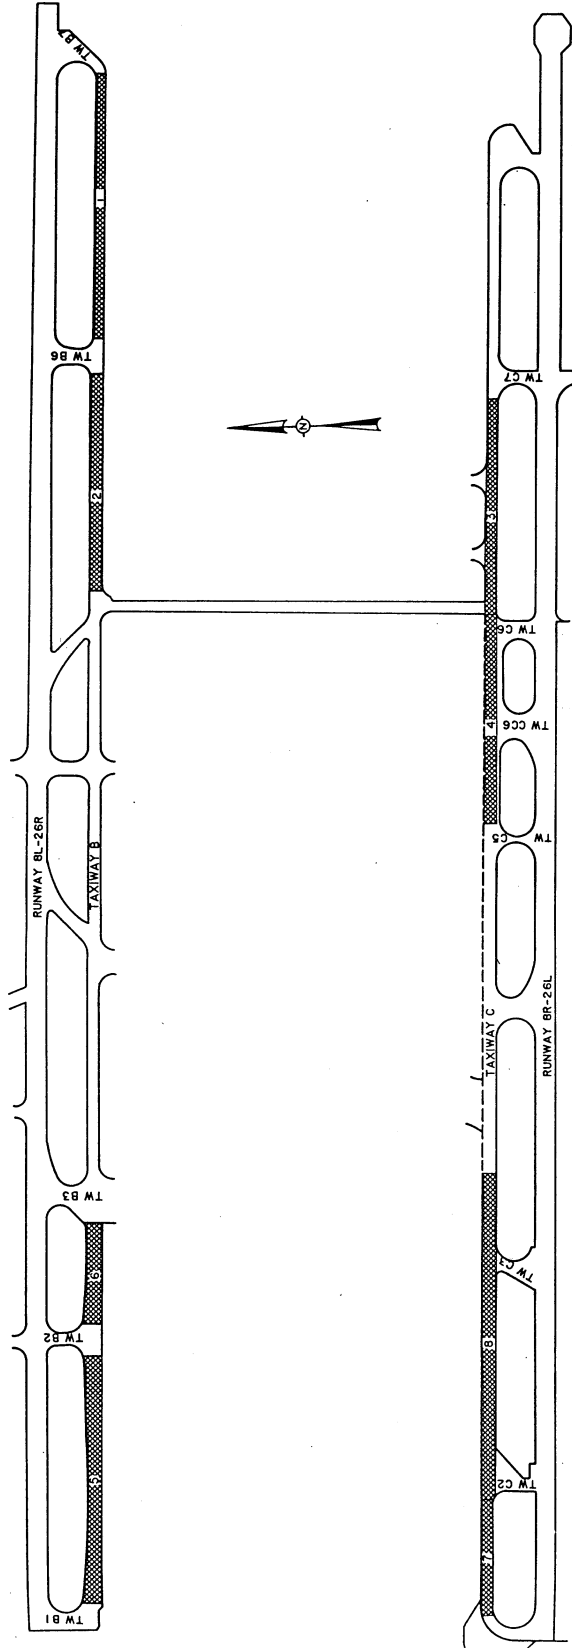
FIGURE C-4. LAYOUT OF PHOENIX SKY HARBOR INTERNATIONAL AIRPORT

Schematic Drawing—Not to Scale
