Use of Surface Treatments to Extend Pavement Life: A Case Study on US 301, Sussex County, Virginia

Final Report VTRC 20-R26

April 2020
VTRC 20-R26

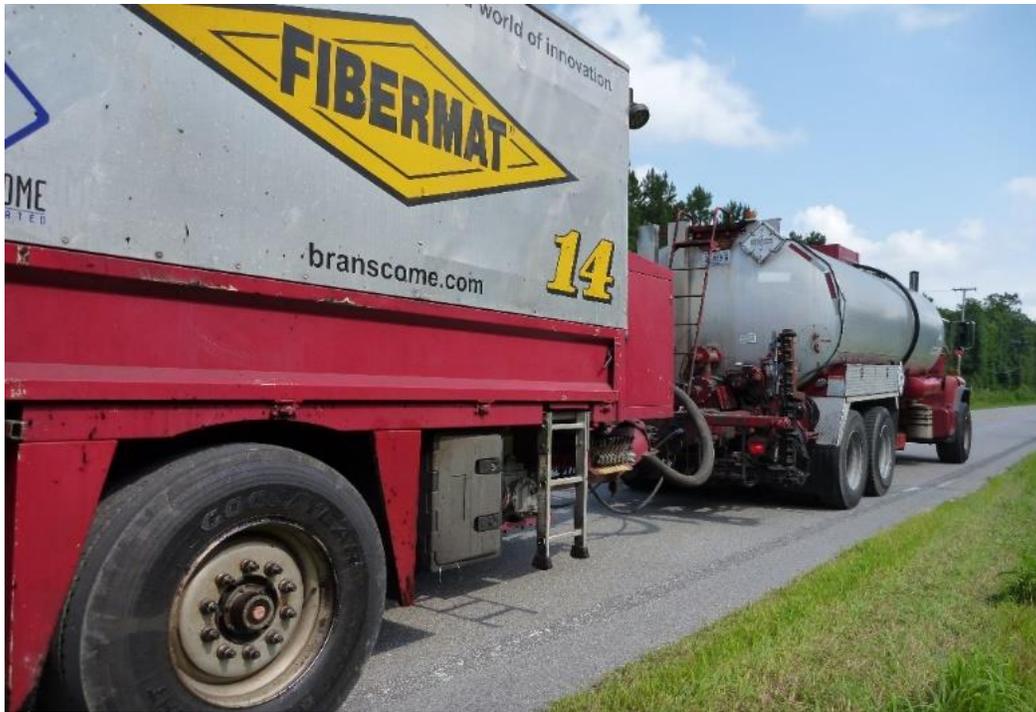
Figure 1 shows the equipment used to apply the FiberMat. It consists of a truck with an emulsion tank and a fiber storage unit. The equipment uses two spray bars with nozzles to spray the emulsion. It also has cutting units between the spray bars, which cut and distribute the glass fibers on the initial emulsion layer (FiberMat, n.d.). The second layer of emulsion encapsulates the fibers into a single membrane layer. Figure 2 illustrates the process of spraying polymer-modified asphalt emulsion and glass fibers on the existing pavement using rows of spray nozzles. Figure 3 depicts the fibers used for the process. The asphalt emulsion used provides the waterproofing membrane, and the glass fiber strands increase its ability to withstand stresses and enhance the tensile properties. Fibers are applied at a nominal rate of 2 to 3 oz/yd², depending on the severity of the cracking. The asphalt emulsion is applied in two simultaneous applications that total 0.4 to 0.6 gal/yd² (Midland Asphalt Materials Inc., n.d.).

Figure 1. FiberMat Placing Equipment

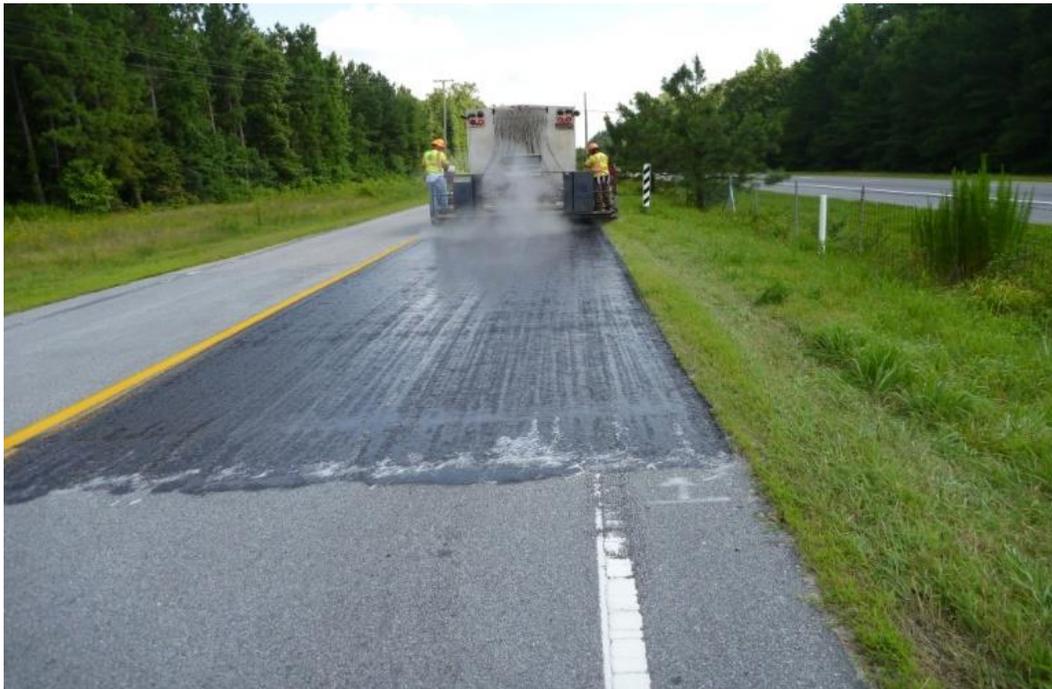
Figure 2. Placement of Fibers and Emulsion

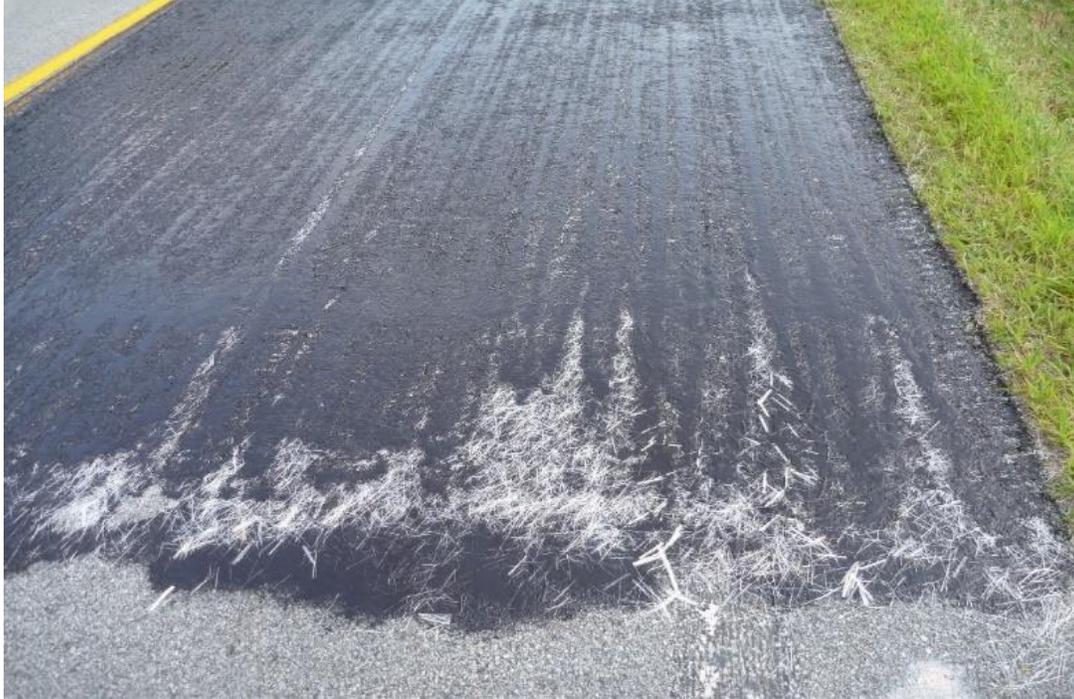
Figure 3. Placement Showing Fibers at Beginning of Section

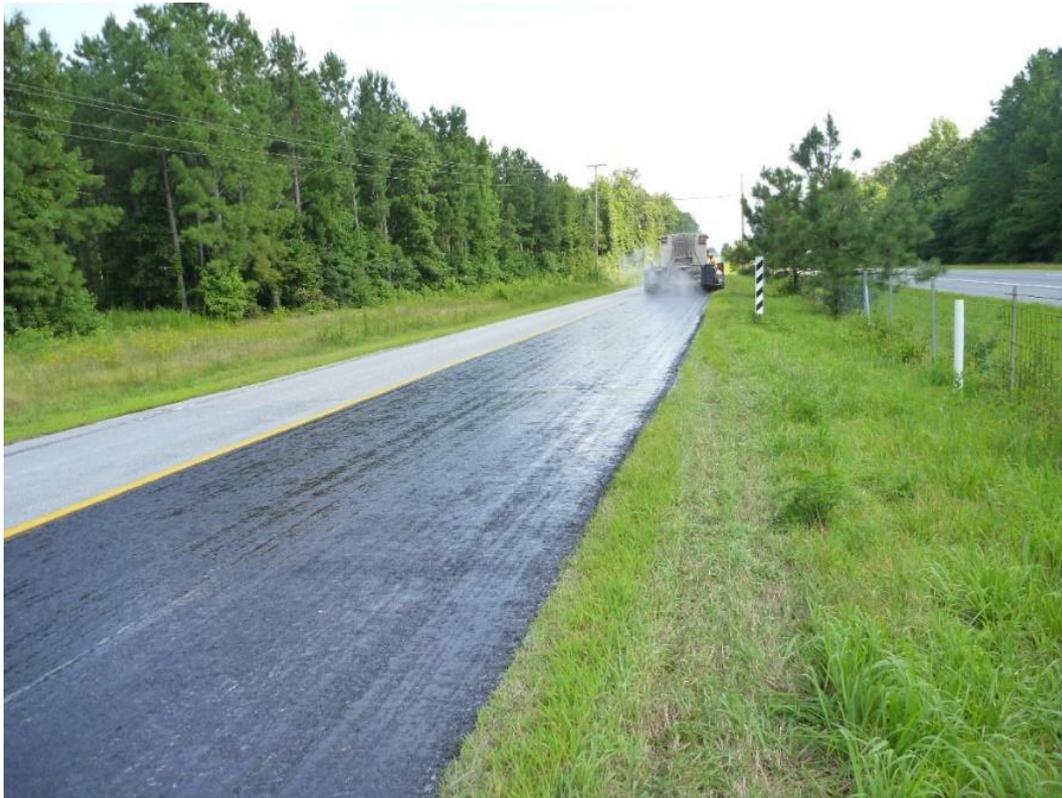
Figure 4. Emulsion With Fibers in Between

The final step in the process includes the application of an aggregate layer. Figures 4 through 6 show the intermediate application of emulsion with fibers, final surface aggregate spreading, and static compaction using steel rollers, respectively. A typical aggregate application rate of 17 to 25 lb/yd² was used (FiberMat, n.d.).

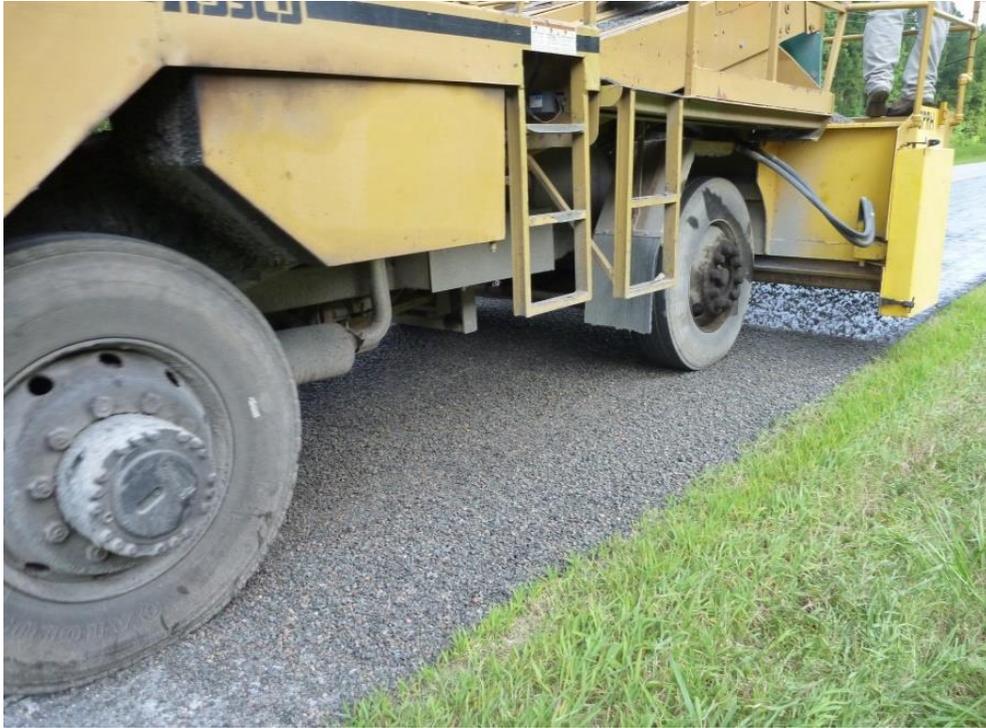
Figure 5. Aggregate Spreading

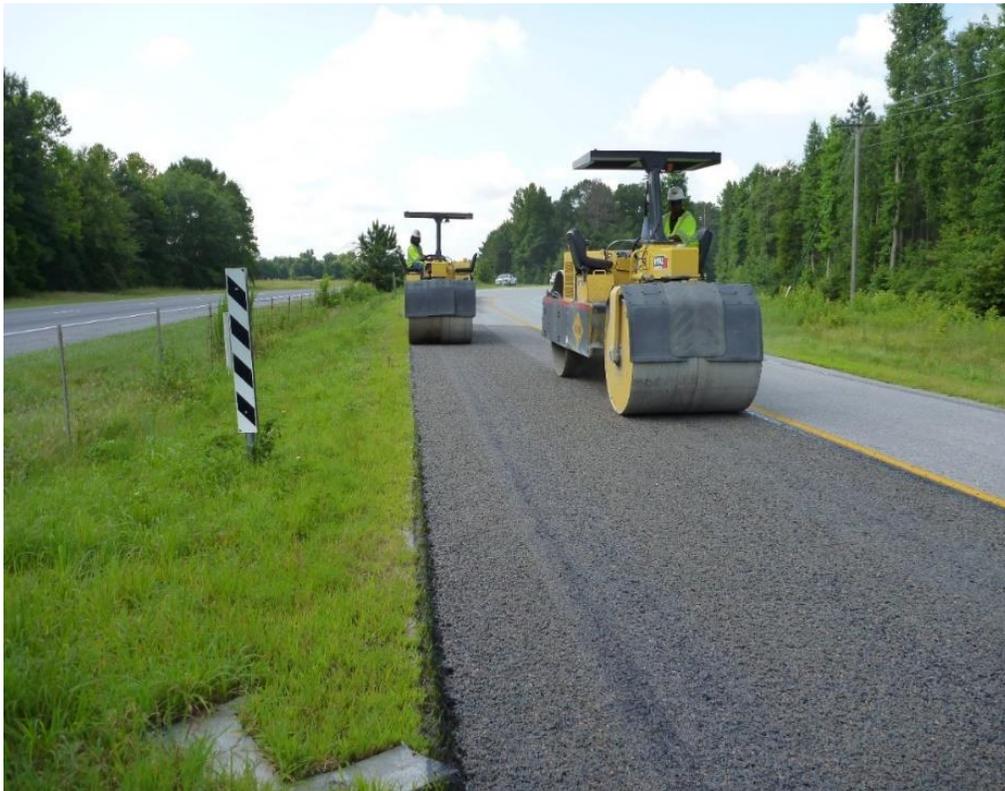
Figure 6. Compaction Using Steel Rollers

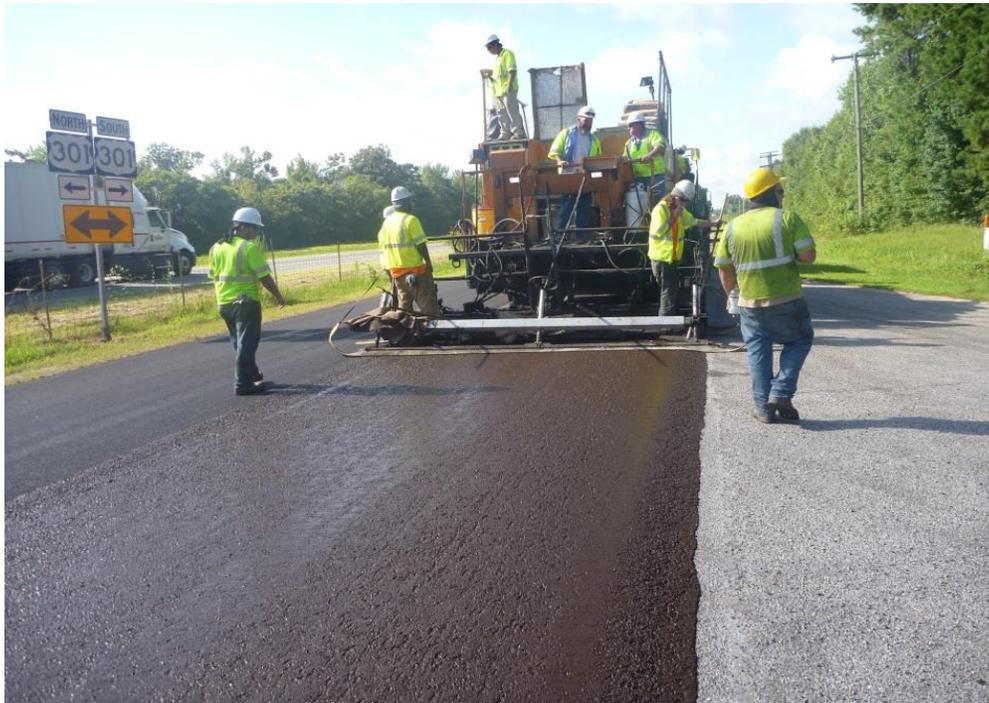
Figure 7. Microsurfacing Placement

Two weeks after the FiberMat and modified chip seal placement, microsurfacing was applied over the entire pavement test section, providing a consistent final wearing surface for all three subsections. As mentioned earlier, the 0.3-mi section (Section 3, MP 12.12 to 12.42) received only a microsurfacing treatment with no underlying chip seal. Figures 7 and 8 show the microsurfacing placement.

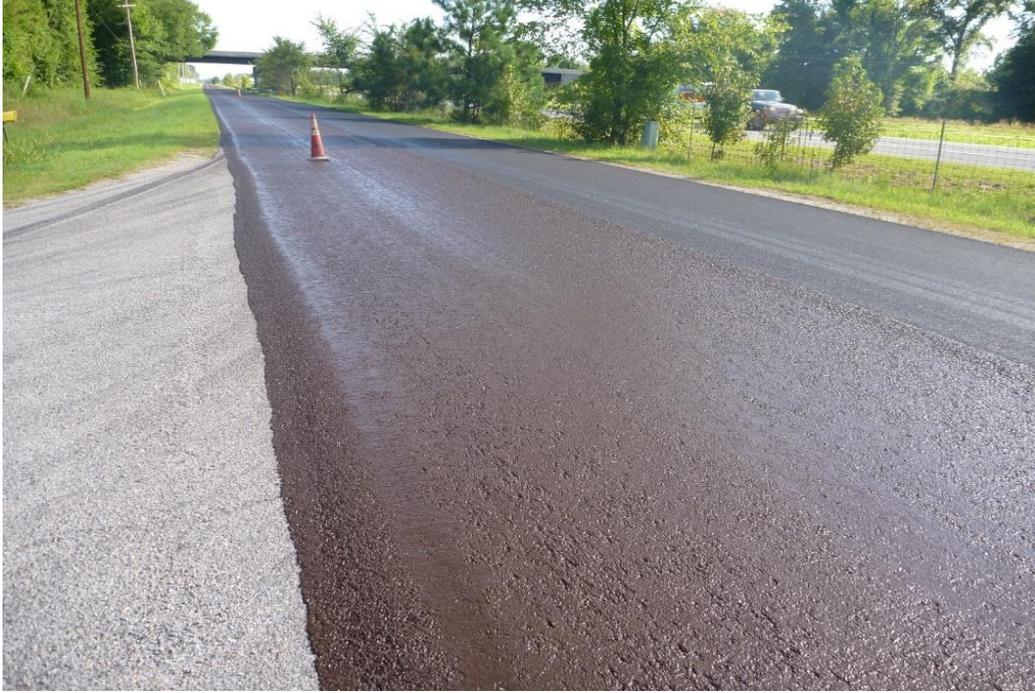
Figure 8. Microsurfacing Before Opening to Traffic

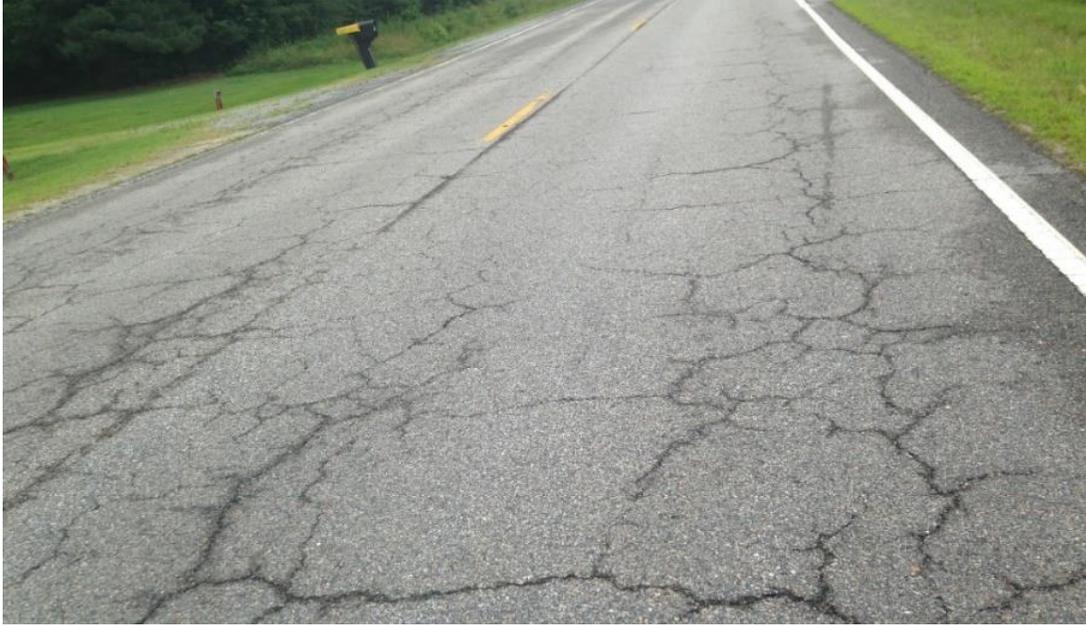
Figure 9. Section With Large Amount of Cracking

A visual distress evaluation was conducted before treatments. Figures 9 through 11 show the existing pavement surface with different levels of cracking. The majority of the cracks were transverse cracks, longitudinal cracks (both on the wheel path and outside the wheel path), and some localized alligator cracks.

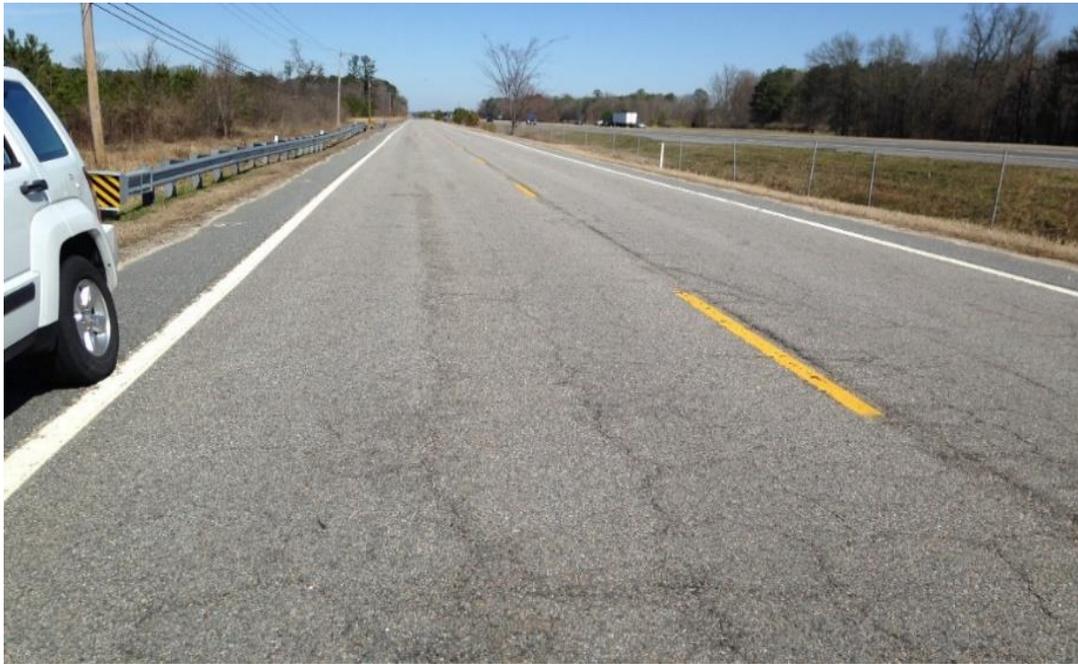
Figure 10. Section With Moderate Amount of Cracking

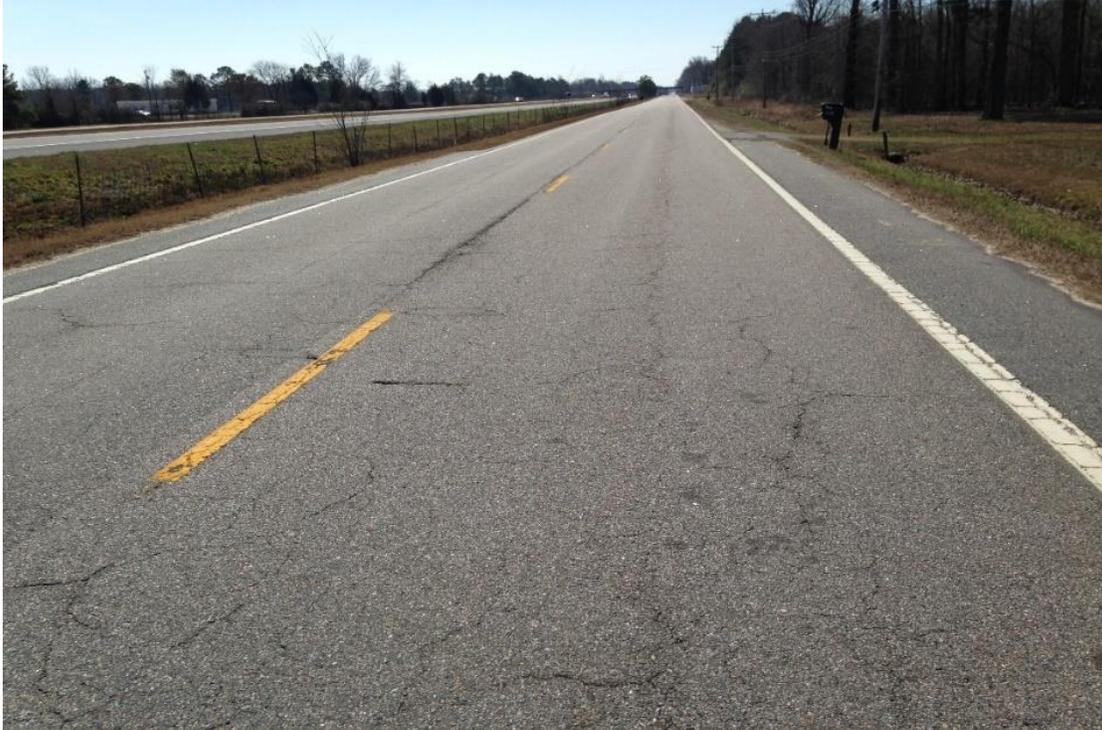
Figure 11. Section With Lower Amount of Cracking

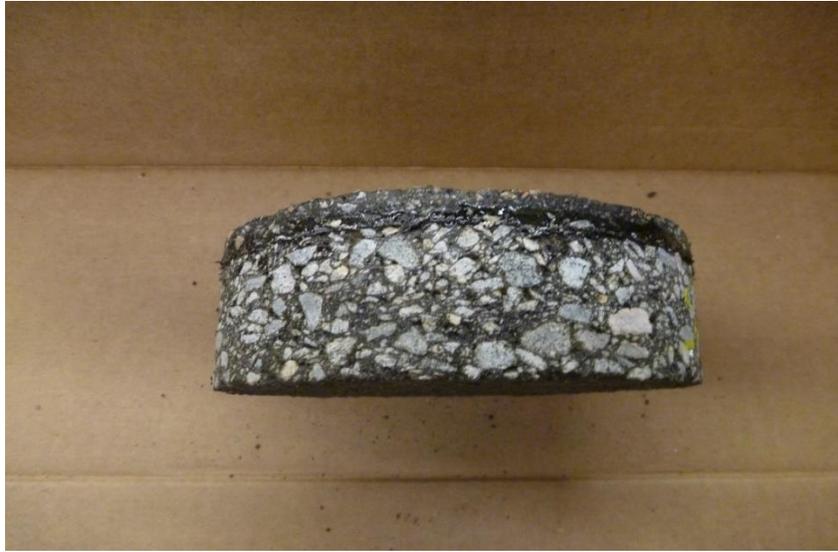
Figure 15. Core Showing FiberMat + Microsurfacing Surface Above Existing Asphalt Top Surface

Figures 15 through 17 show cores obtained from fiber-reinforced cape seal, regular cape seal, and microsurfacing sections, respectively. From Figure 15, a clear interface is seen between the existing top asphalt surface and the FiberMat because of thicker emulsion with fibers. Figure 18 shows a surface picture of microsurfacing treatment after curing. Four full-depth cores were collected from the north end of the section, and Figure 19 shows a full-depth asphalt core. Full-depth cores had an average asphalt thickness of 7 in. All full-depth cores were intact (no delamination).

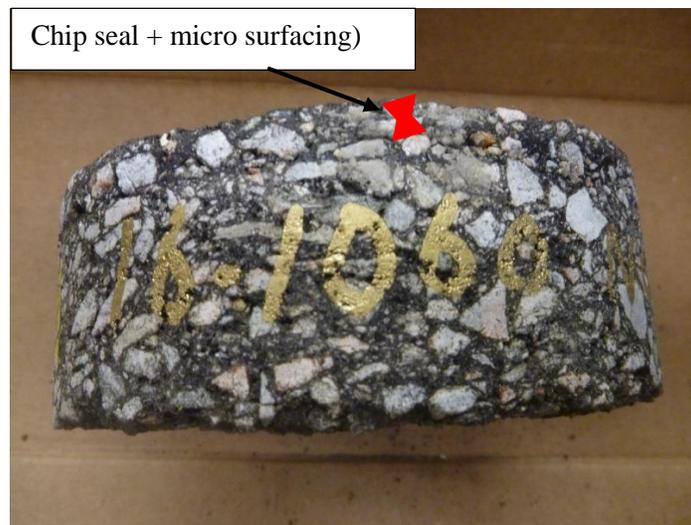
Figure 16. Core Showing Chip Seal + Microsurfacing Above Existing Asphalt Top Surface

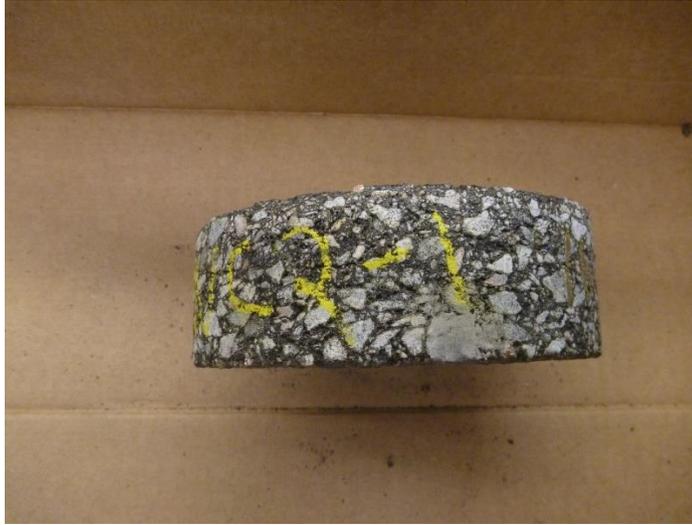
Figure 17. Core Showing Microsurfacing Above Existing Asphalt Top Surface

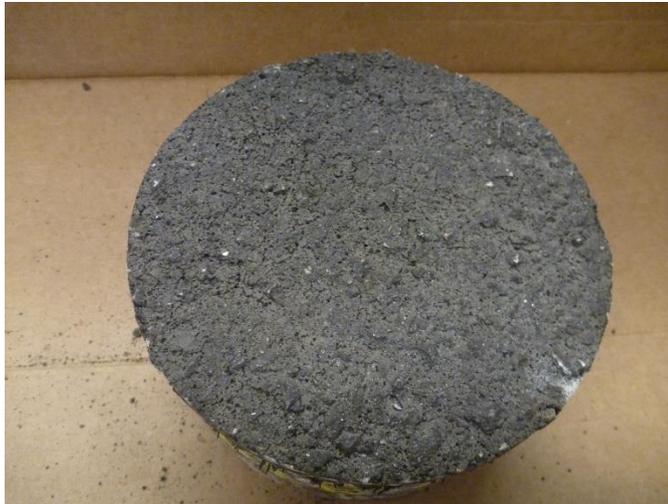
Figure 18. Final Pavement Surface With Microsurfacing

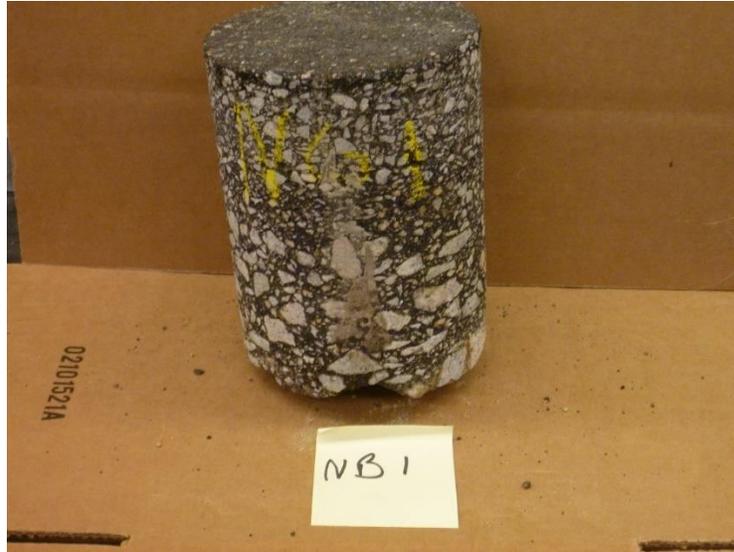
Figure 19. Full-depth Core

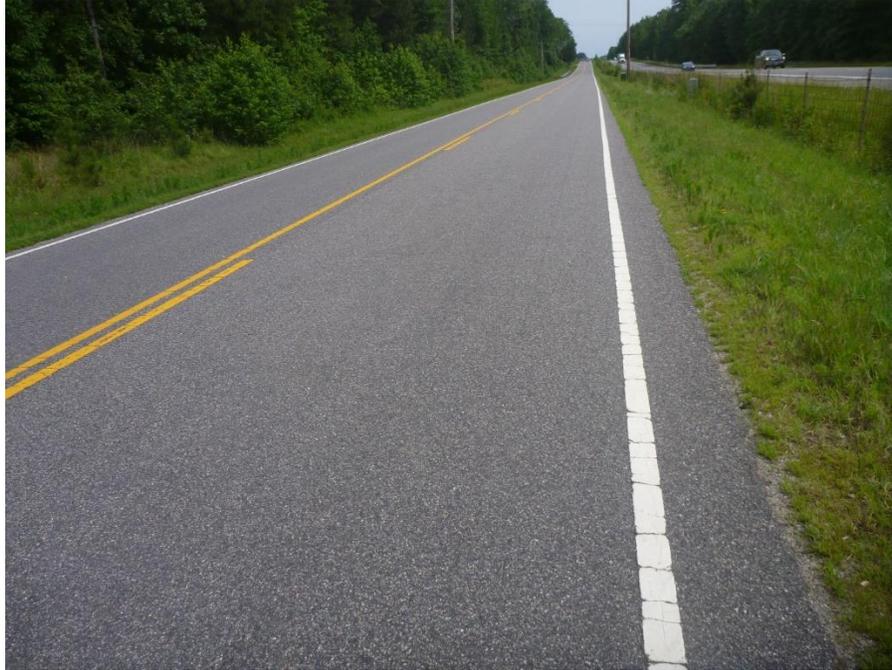
Several visual evaluations were conducted over the first 3 years in service. The annual average daily traffic for US 301, Sussex County, was 612 in the southbound direction and 715 in the northbound direction. Overall, the fiber-reinforced cape seal section (Section 1) is performing well with very little reflective cracking (mostly transverse cracks). Figure 20 shows the fiber-reinforced cape seal surface after 3 years. Figure 21 shows a close-up view of the surface texture of the fiber-reinforced section.

Figure 20. FiberMat With Microsurfacing After 3 Years

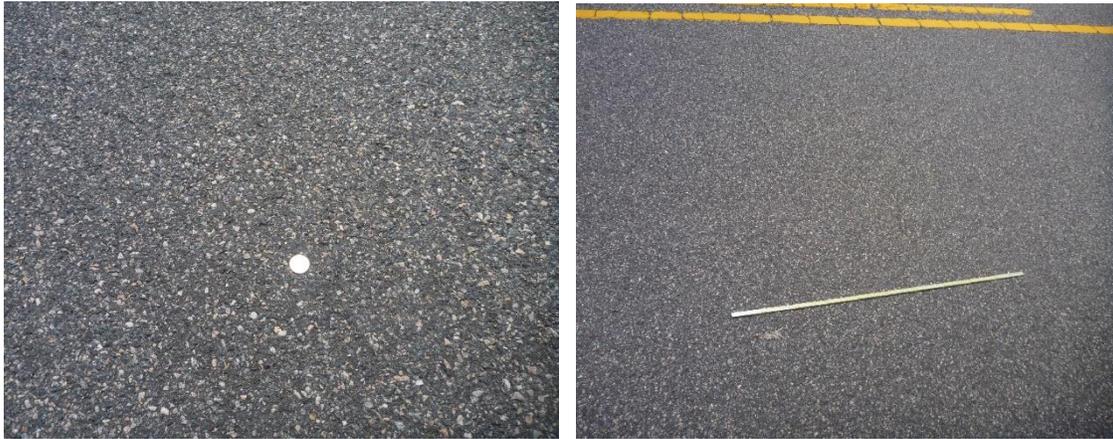
Figure 21. Surface Texture of FiberMat With Microsurfacing After 3 Years

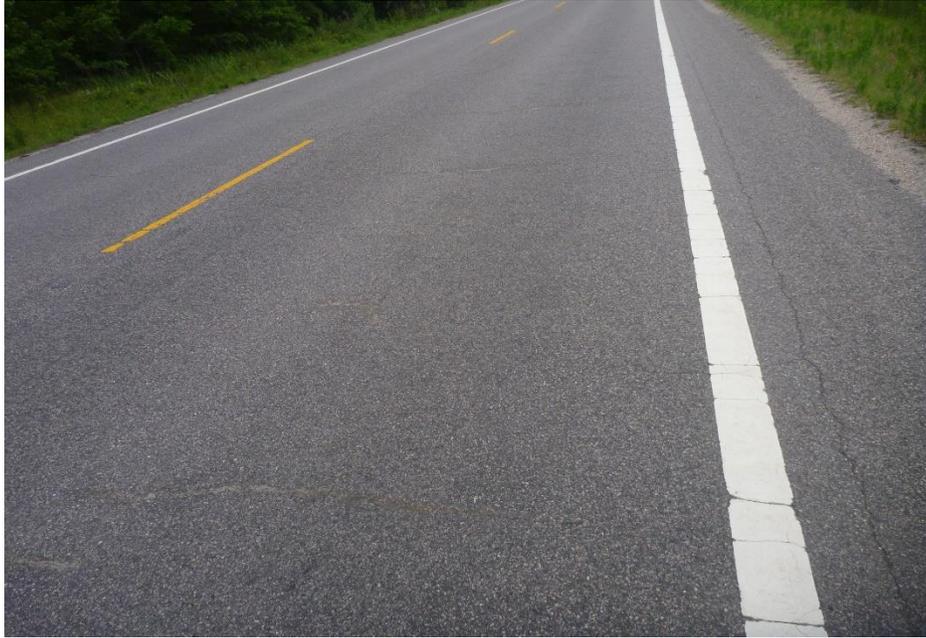
The regular cape seal section (Section 2) was also performing well, but reflective cracking was higher compared to the fiber-reinforced cape seal section (Section 1). Figure 22 shows the modified single seal with microsurfacing after 3 years.

Figure 22. Modified Single Seal With Microsurfacing After 3 Years

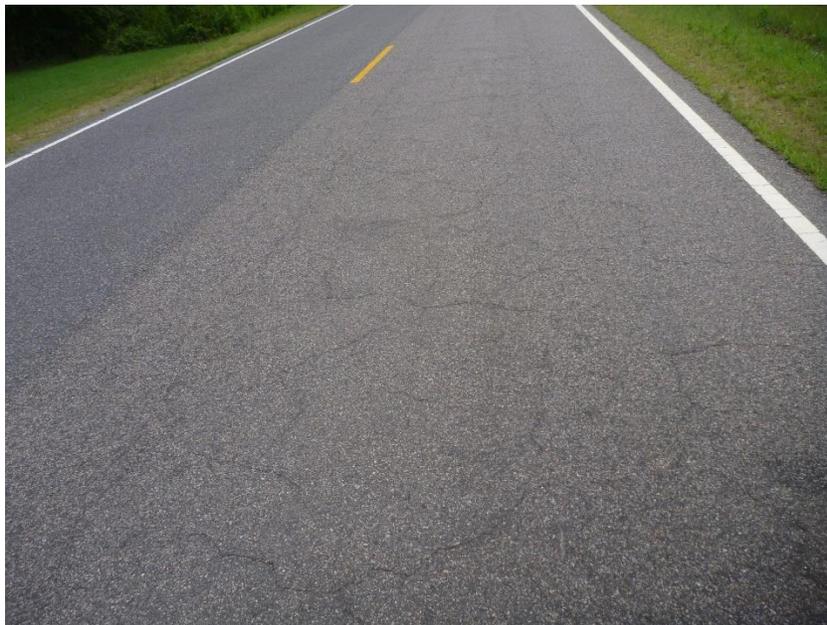
The section with microsurfacing alone showed the largest amount of reflective cracking. Delamination of the microsurfacing was also found in several places. Figure 23 shows the microsurfacing section (Section 3) with considerable cracking.

Figure 23. Microsurfacing Section After 3 Years

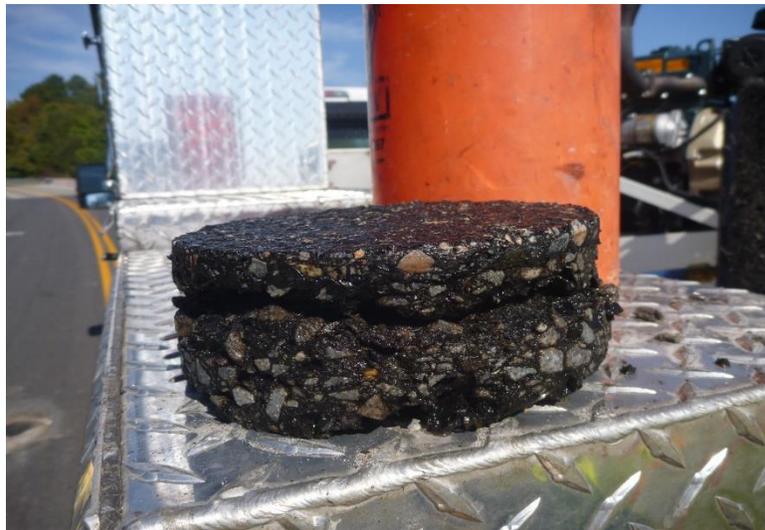
Four months after the treatments, a segment near the end of the northbound FiberMat cape seal section (200 ft long, approximately at MP 14.2) began to exhibit early cracking. FWD testing showed higher deflections in this segment, and a forensic investigation revealed moisture damage and delamination in the underlying asphalt layer, as shown in Figure 24. If subsurface drainage of the pavement is inadequate, moisture and/or moisture vapor can move upward

because of capillary action and saturate the asphalt courses. An impermeable layer on top (such as a microsurfacing treatment) can accelerate the existing moisture damage. The damaged section was removed and patched with new asphalt concrete.

Figure 24. Core Showing Moisture Damage and Delamination
