Chip Seal Maintenance

Solutions for Bleeding and Flushed Pavement Surfaces

William D. Lawson and Sanjaya Senadheera

Transportation Research Record: Journal of the Transportation Research Board, No. 2108, Transportation Research Board of the National Academies, Washington, D.C., 2009, pp. 61–68.
DOI: 10.3141/2108-07

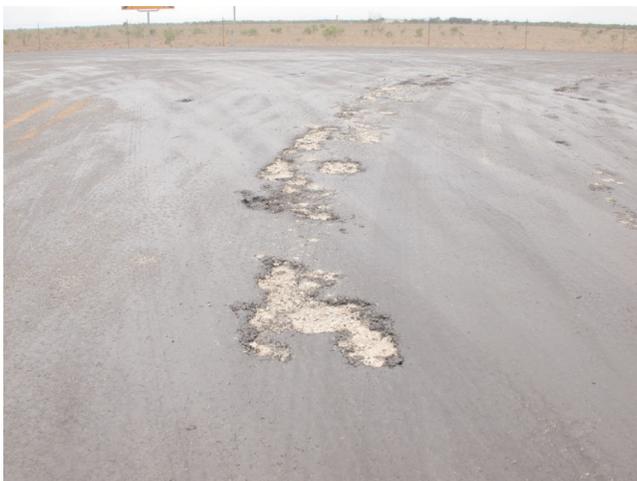
FIGURE 1 Pavement delamination—picking up of a chip seal—as result of bleeding.

One of the ways bleeding manifests itself is during the chip seal construction process when the pavement is first opened to traffic, before the binder has fully cured. The other typical manifestation results from heavy traffic drawing asphalt binder to the surface during extended periods of high temperatures. The key factor is that the asphalt binder is no longer in solid form. Bleeding asphalt sticks to aggregate and tires and causes tracking. When the bleeding pavement is left unattended, this can result in the chip seal aggregate rolling over and being picked up, especially for fresh seals. This can lead to pitting out or pulling up chunks of pavement—that is, “slinging” instead of singing—effectively ruining the seal (Figure 1). Functionally, bleeding is considered a failure and must be addressed through corrective, reactive, and in some cases, emergency, maintenance.

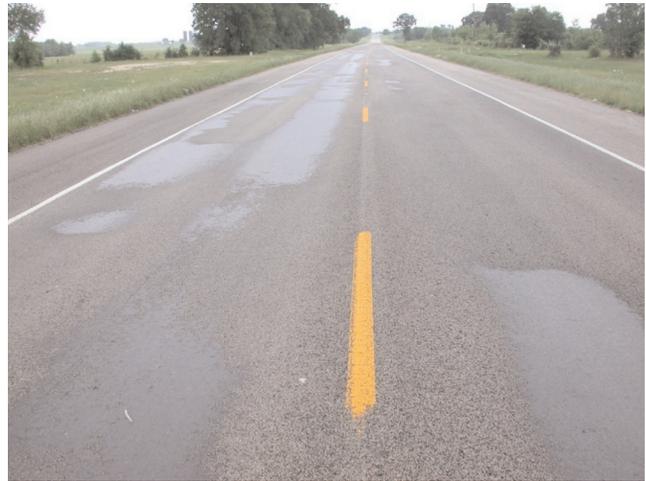
FIGURE 2 Chip seal with flushing in wheelpaths.

Progressive wearing down of aggregate is common during the typical life cycle of a properly constructed chip seal, giving rise to a flushed pavement surface. Depending on the degree of severity, flushed areas may be discolored or darker (low severity), experience a loss of surface texture (moderate severity), or have a shiny, glossy appearance showing tire marks in warm weather (high severity). The excess asphalt associated with flushed pavement frequently appears in the wheelpaths (Figure 2).

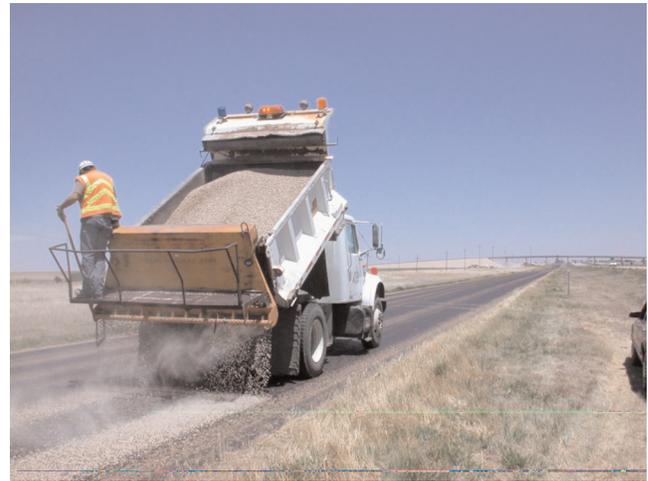
FIGURE 3 Applying small-sized aggregate to treat bleeding chip seal.

The application of small-sized aggregate [(Texas DOT Standard Specification Item 302: Grade 5, nominal size 0.19 in. (4.75 mm/No. 4 sieve)] (15) is the most commonly used maintenance solution for the treatment of bleeding chip seals in Texas.

Maintenance forces and construction contractors use this option if there is enough free asphalt on the pavement surface to stick the rock. This method is typically used to treat light to moderate bleeding. The key with any aggregate remedy is to get the rock to adhere to the pavement surface, and the primary objective is to get the tires out of the asphalt (Figure 3).

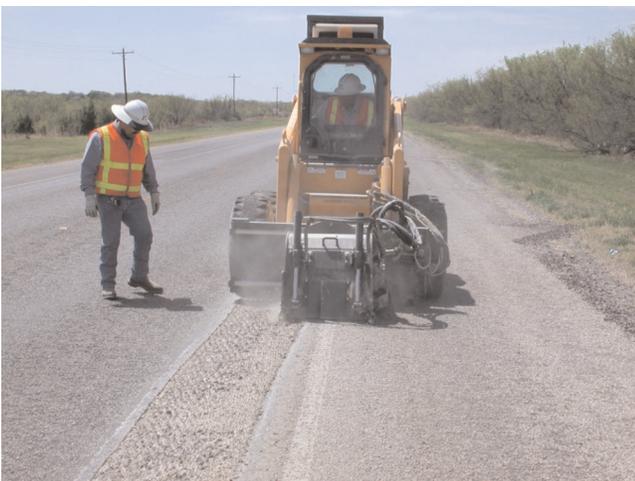
FIGURE 4 Cold milling to retexture flushed pavement in wheelpaths.

Cold milling is the controlled removal of the surface of the existing pavement to the desired depth, with specially designed milling equipment (Figure 4). Milling is done either to prepare the surface to receive overlays (by removing rutting, flushing, and surface irregularities), to restore the pavement cross slopes and profile, or to reestablish the pavement's surface friction characteristics. The typical application is where rutting has occurred in the wheelpaths, water accumulates during rains, and skid resistance and hydroplaning are a concern. Milling is also used quite often at intersections where heavy starting and stopping movements have caused rippled, bumped, and otherwise rough pavement surfaces.
